ABORIGINAL CULTURAL HERITAGE IMPACT ASSESSMENT

Hexham Wind Farm

Hexham, Victoria

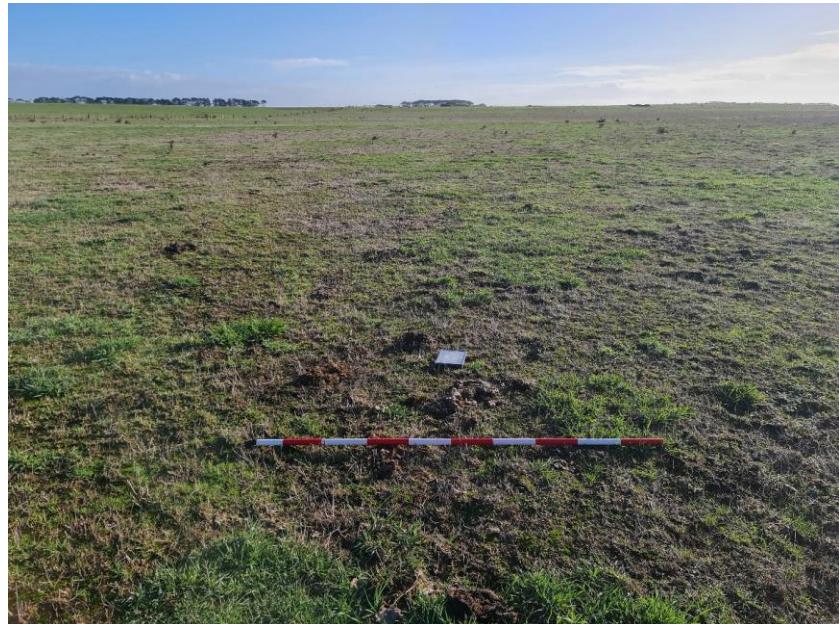
Photo 26

SA1: Location of possible mound 113, north of Turbine 11, GSV was very good. The ground was churned by cattle, and no evidence for a mound was observed.

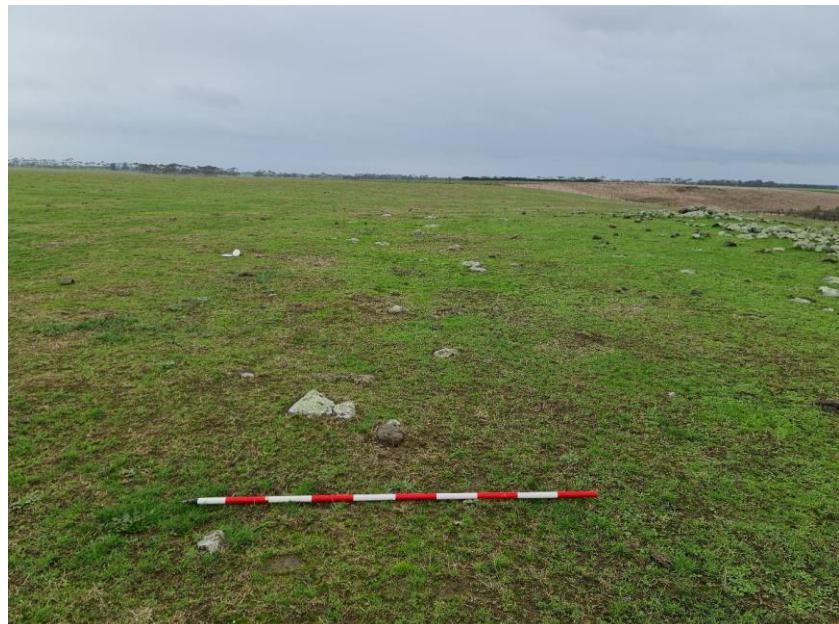
Photo 27

SA1: location of possible mound 127, north of Turbine 17, GSV was very good. No evidence for a mound was observed. The location was identified as a stony rise.

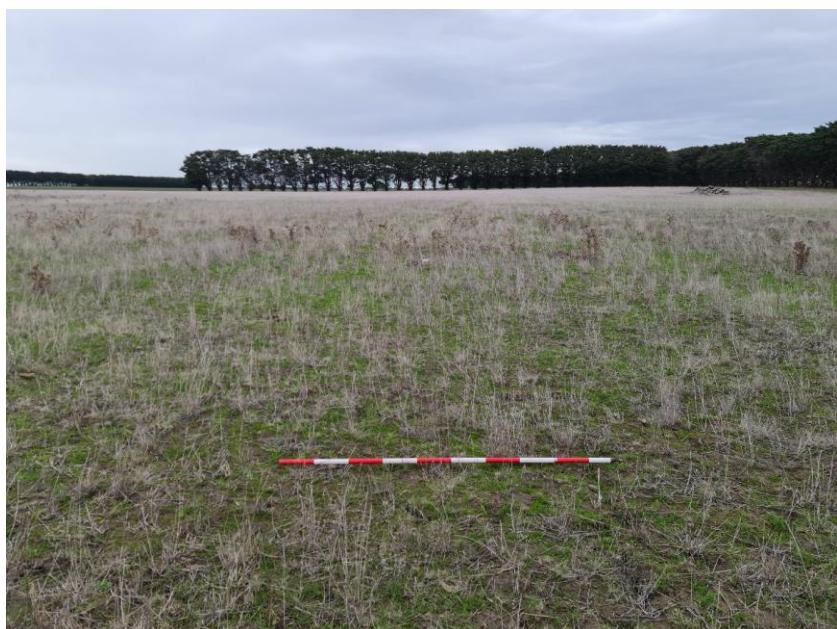
Photo 28

SA1: location of a possible mound 117, corner of Emmersons and Keilors Rds. GSV was fair. No evidence for a mound was observed. The next 4 photos relate to a cluster in the same location.

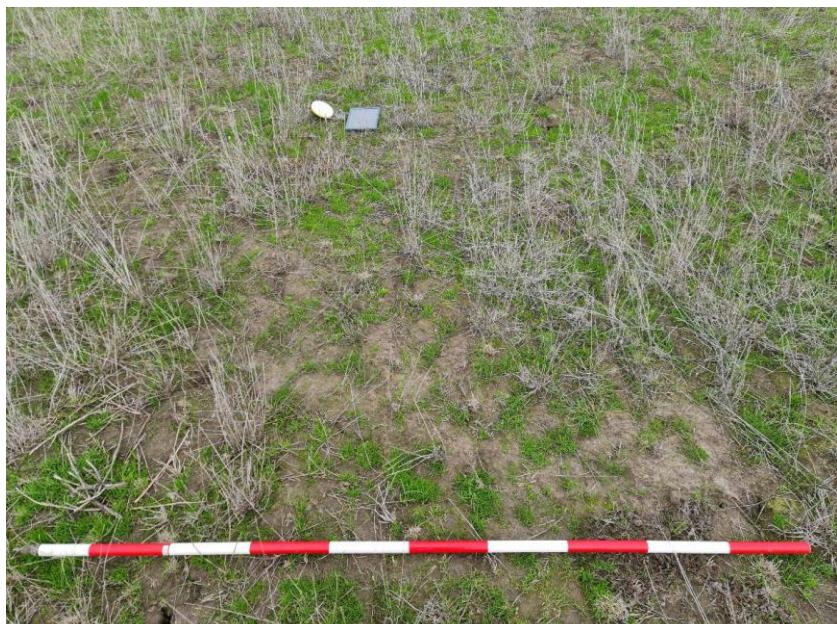
Photo 29

SA1: Location of a possible mound 136. GSV was very good. No evidence for a mound was observed. Close-up of a feature in the landscape seen above.

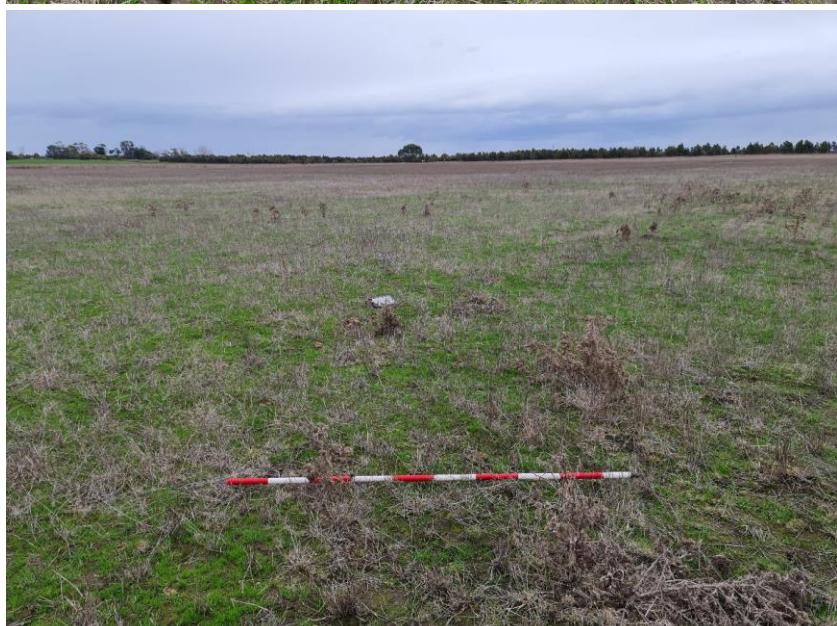
Photo 30

SA1: Location of a possible mound 133. GSV was good. No evidence for a mound was observed.

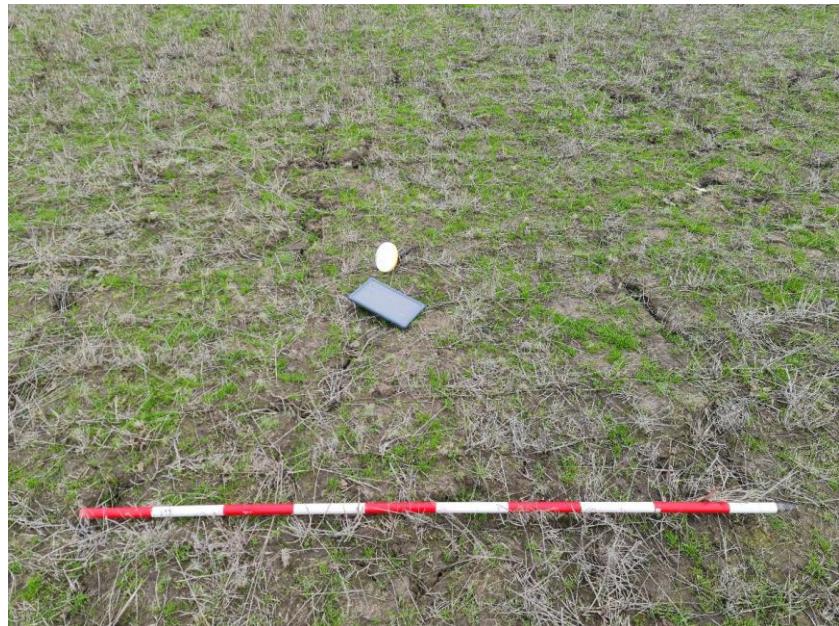
Photo 31

SA1: location of a possible mound 135. GSV was fair. No evidence for a mound was observed. Close-up of a feature in the landscape seen above.

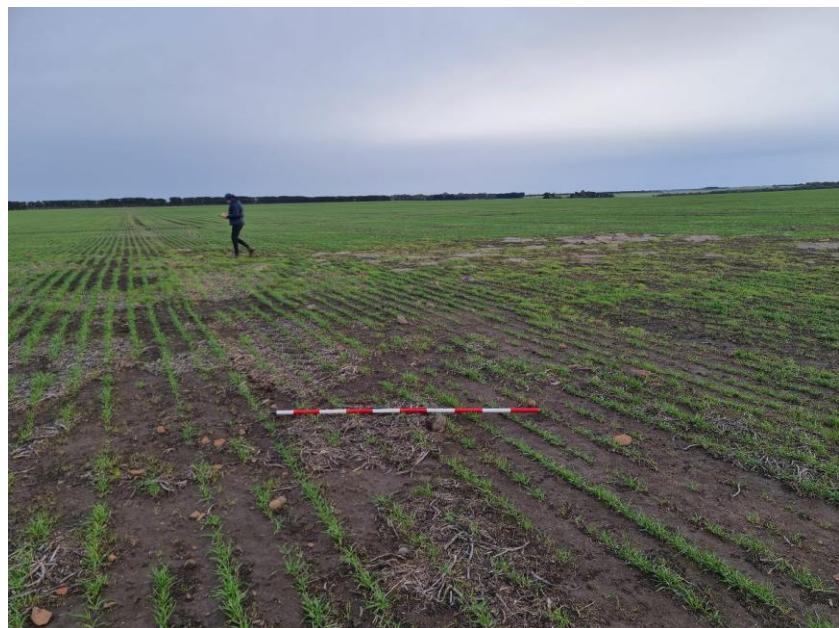
SA2: location of possible mound 213, South of Turbine 33. GSV was very good. The dark soil colour appears to be associated with the removal of basalt floaters across this low profile basalt exposure.

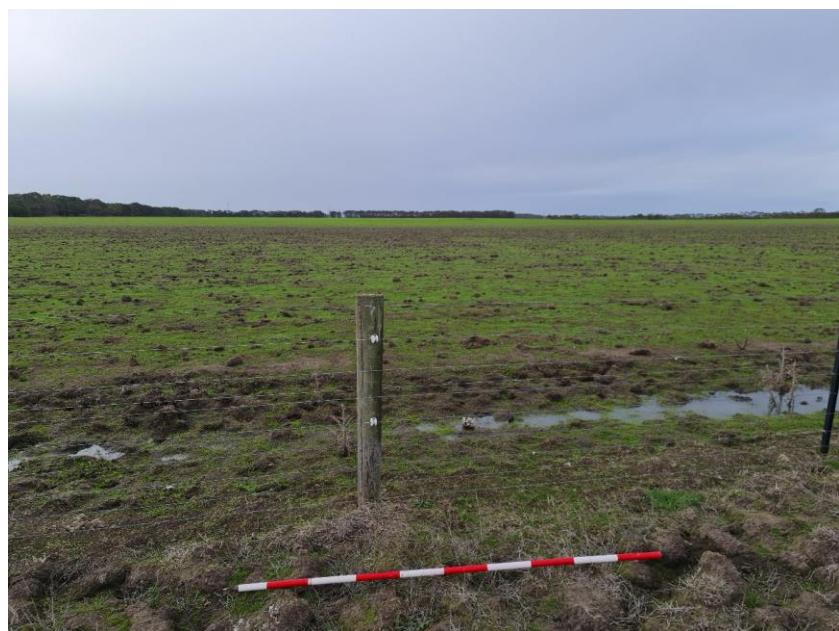
Photo 43

SA2: location of possible mound 165, south of Turbine 23. GSV was very good. No evidence for a mound was observed.

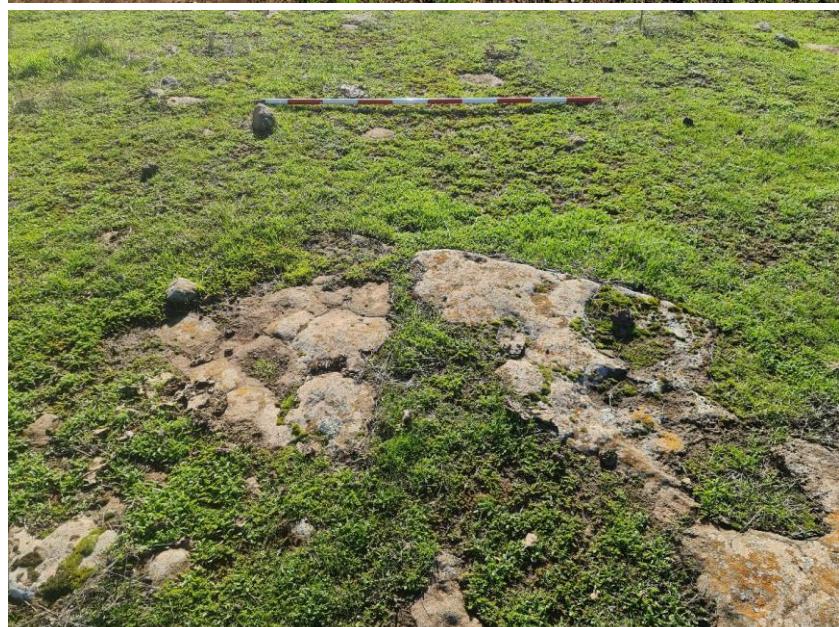
Photo 50

SA2: location of possible mound 333, west of the Coomete access gate. GSV was very good. No evidence for a mound was observed, substantial stony rise.

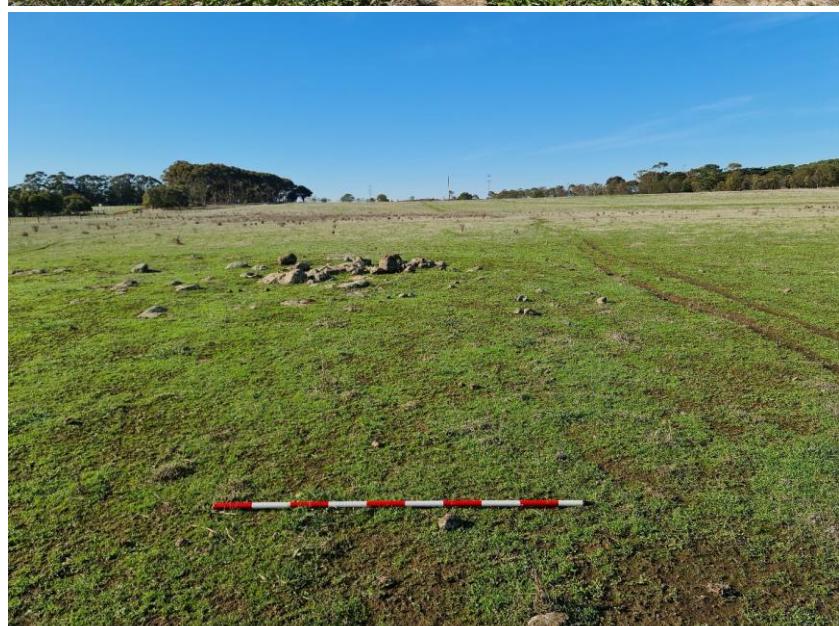
Photo 51

SA2: Location of possible mound 335, west of the Coomete access gate. GSV was very good. No evidence for a mound was observed, substantial stony rise.

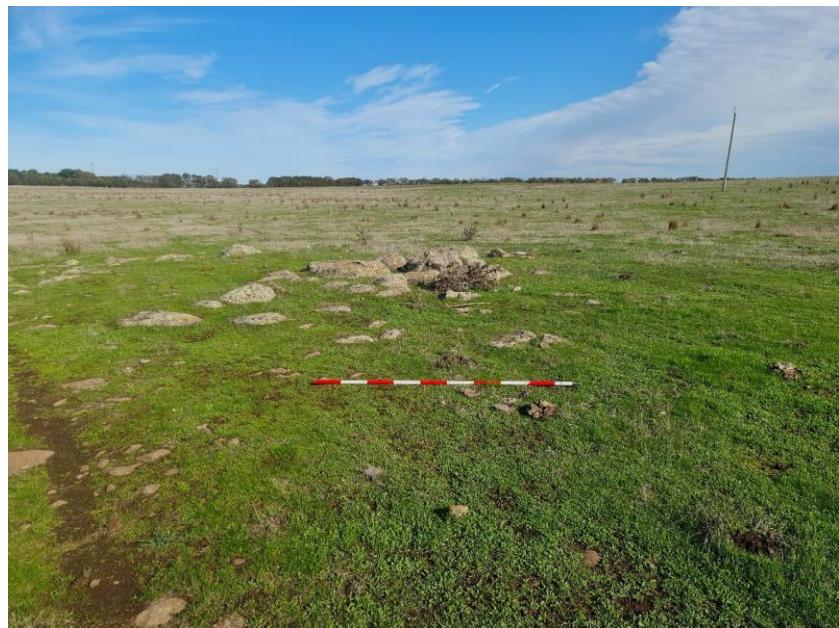
Photo 52

SA2: Location of possible mound 334, west of the Coomete access gate. GSV was very good. No evidence for a mound was observed, substantial stony rise.

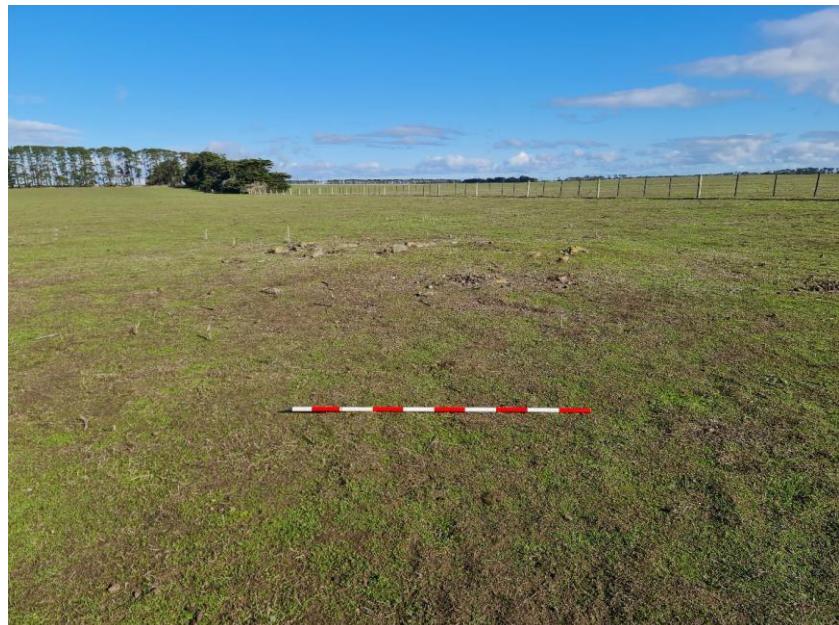
SA3: location of possible mound 336, adjacent to the overhead powerlines, between Woolsthorpe-Hexham Rd and Immigrants Ln. GSV was very good. No evidence for a mound was observed, low profile basalt exposure.

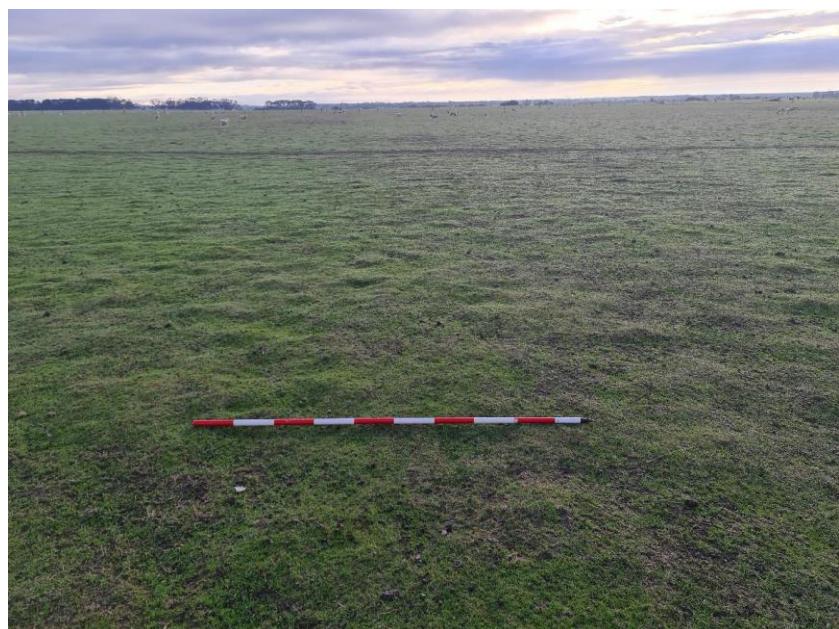
SA3: proposed location of Turbine 103, south of Hexham-Ballangeich Rd, and Turbine 96. Small gilgai or crabholing visible with micro-mounds across the surface. GSV was good.

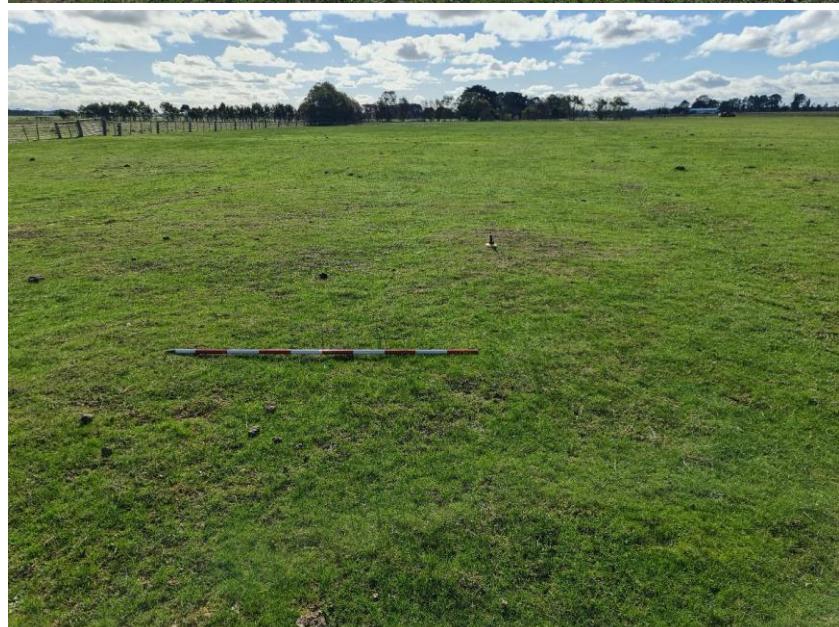
Photo 75

SA3: location of possible mound 459, adjacent to the MET mast. GSV was good. No evidence for a mound was observed.

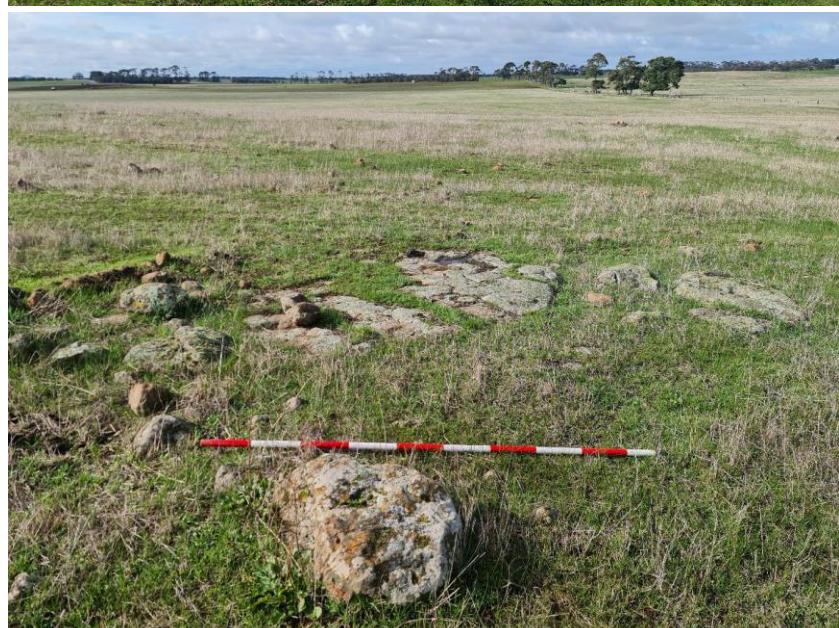
Photo 76

SA3: proposed location of MET mast, north of Gordons Ln. GSV was good.

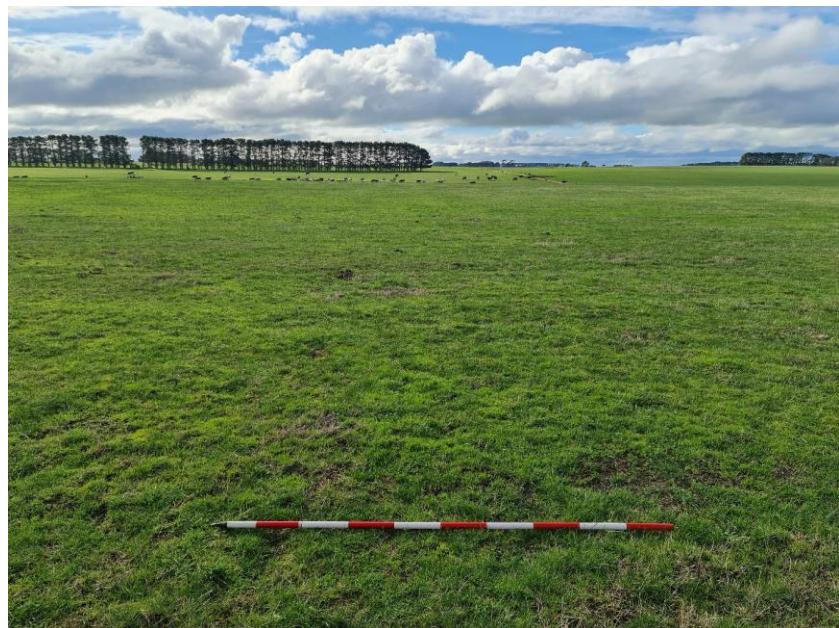
Photo 77

SA3: location of possible mound 344, adjacent to Turbine 63. GSV was good. No evidence for a mound was observed.

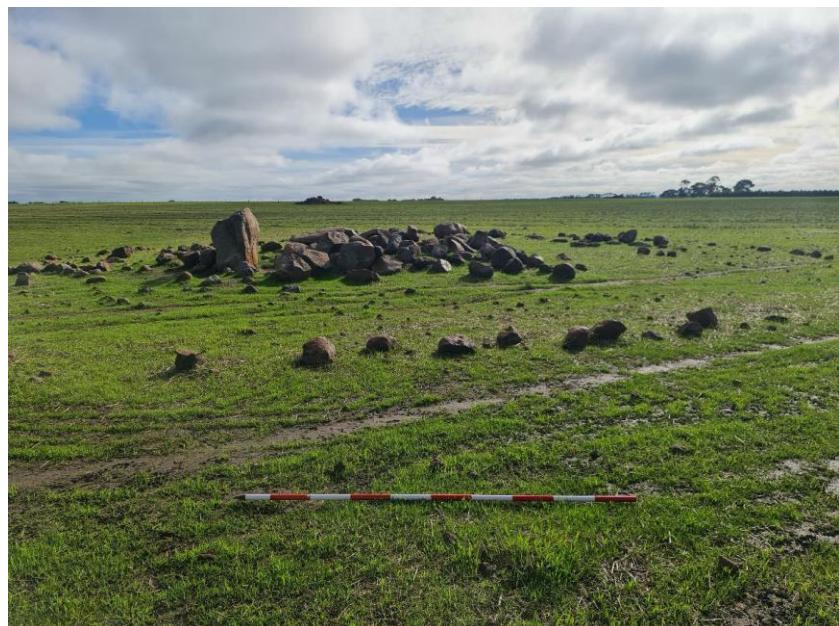
Photo 96

SA4: location of possible mound 331. GSV was good. No evidence for a mound was observed, appears to be a rock dump from early land clearing.

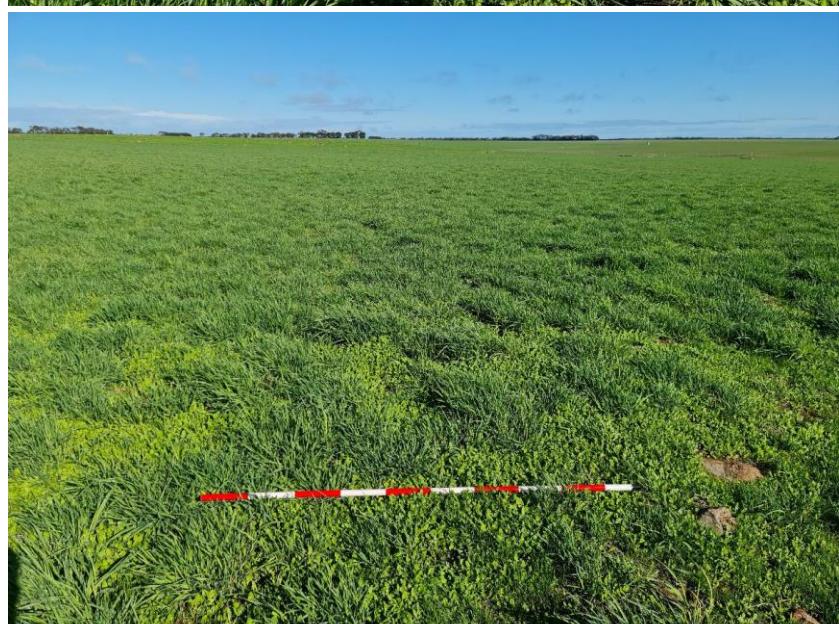
SA4: location of possible mound 317. GSV was poor. Appears to be a small cluster of basalt adjacent to possible mound 316.

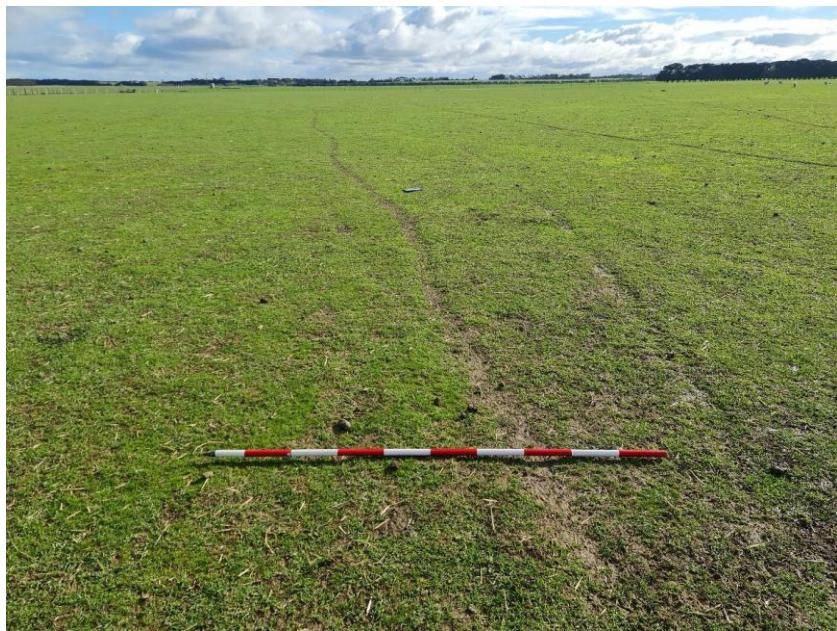
Photo 104

SA4: location of possible mound 349. GSV was good. No evidence for a cultural mound was observed.

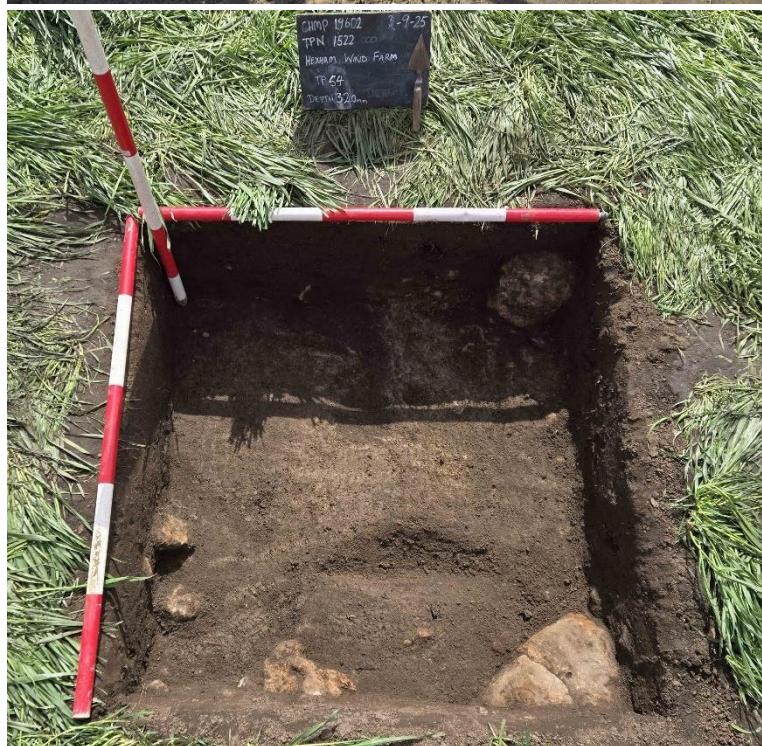
TP54 after excavation at possible mound (Map 7c).

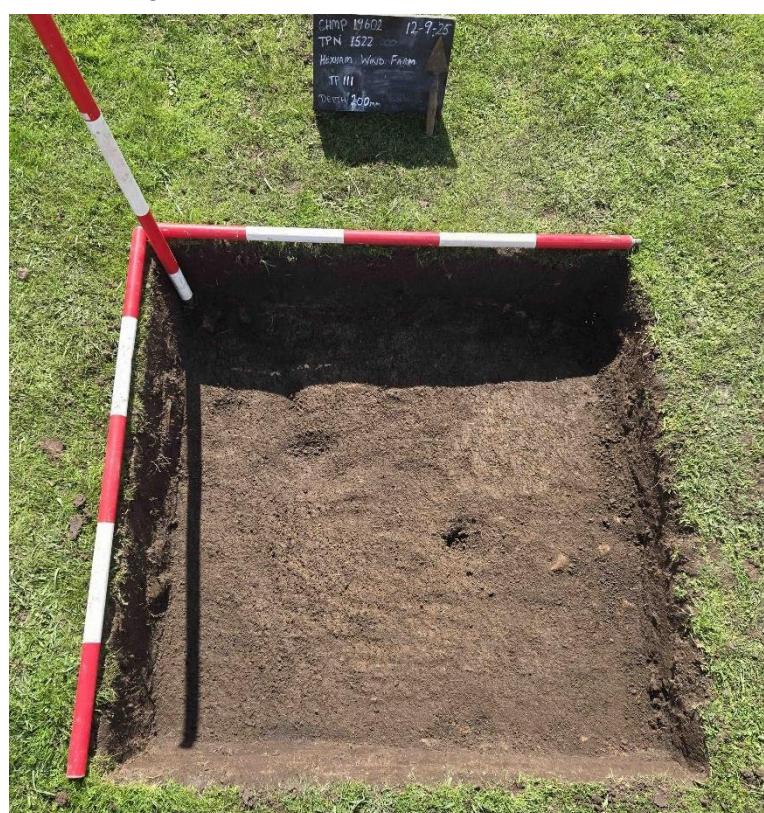
TP111 after excavation (Map 7d).

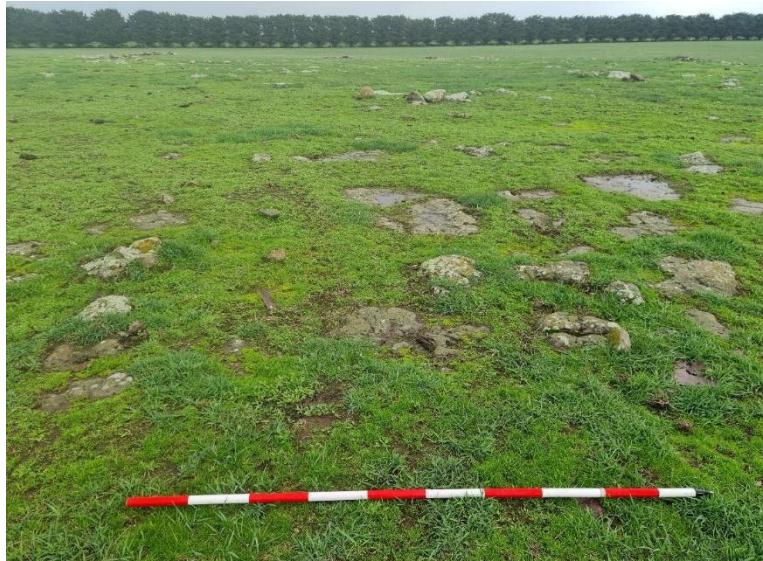
Proposed quarry site showing basalt floaters on ridgeline surface.
