A.6. Dwelling Assessment Dwelling D29

A.8. Dwelling Assessment Dwelling D299

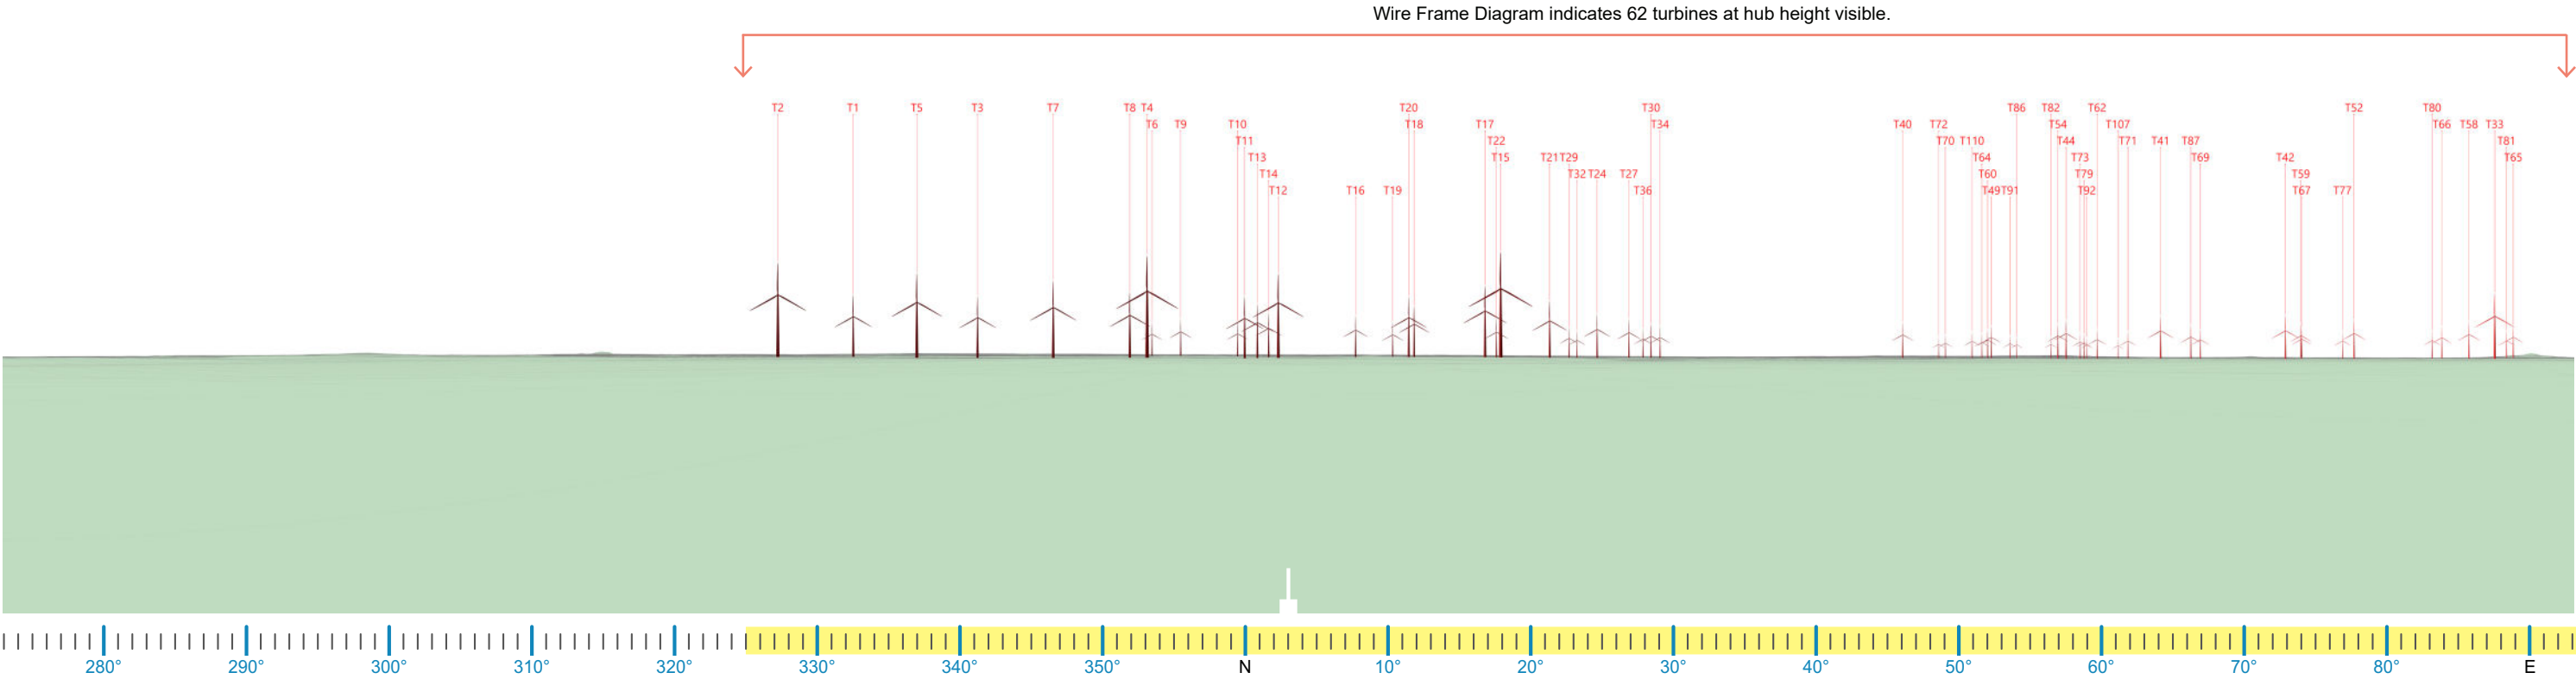
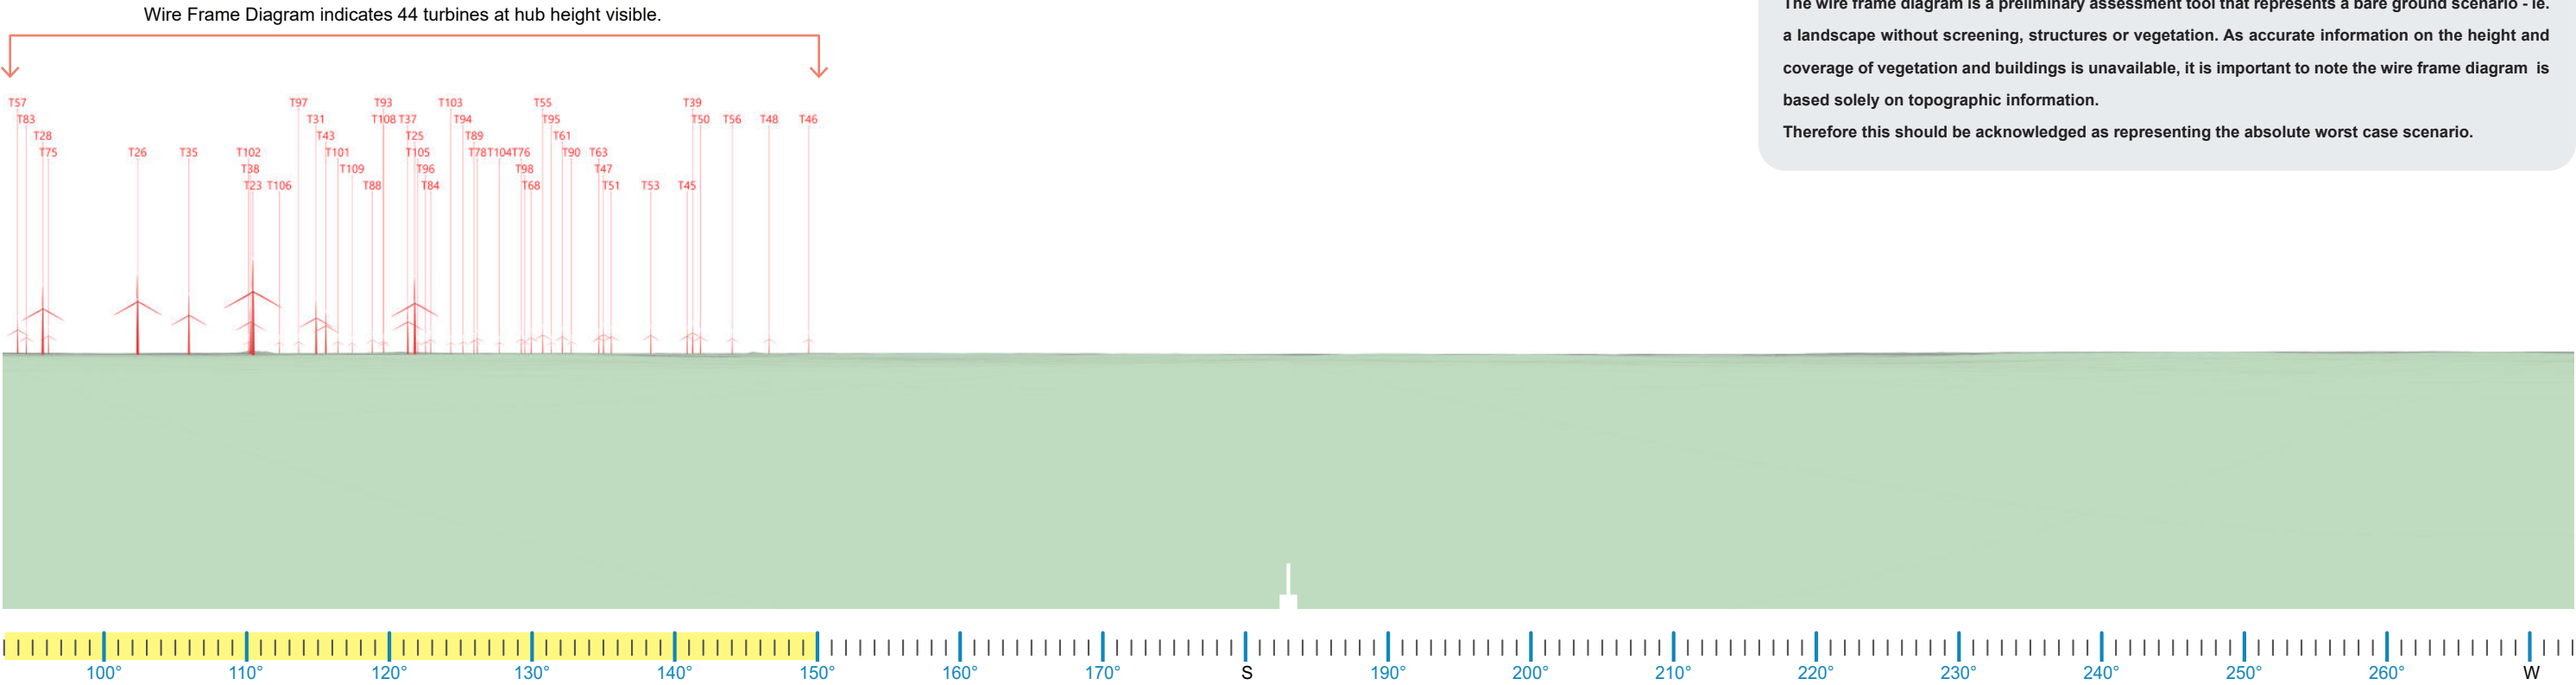
Proposed Wire Frame Diagram - 180 degree field of view

A wire frame diagram has been prepared for this assessment as access to the dwelling was not available. The wire frame diagram indicates all (106) turbines would theoretically be visible at hub height based on topography alone. The nearest turbine to the dwelling is located approximately 1.99 km away. Based on 3D assessment, views of the Project are theoretically available in the north, east and southeast. Aerial imagery indicates that the dwelling is surrounded by dense vegetation in the foreground in all directions. It is likely that existing vegetation will limit views to the Project. The visual impact resulting from the Project has been rated as **Low**.

Note:
No access to Site was available.
The wire frame diagram is a preliminary assessment tool that represents a bare ground scenario - ie. a landscape without screening, structures or vegetation. As accurate information on the height and coverage of vegetation and buildings is unavailable, it is important to note the wire frame diagram is based solely on topographic information.
Therefore this should be acknowledged as representing the absolute worst case scenario.

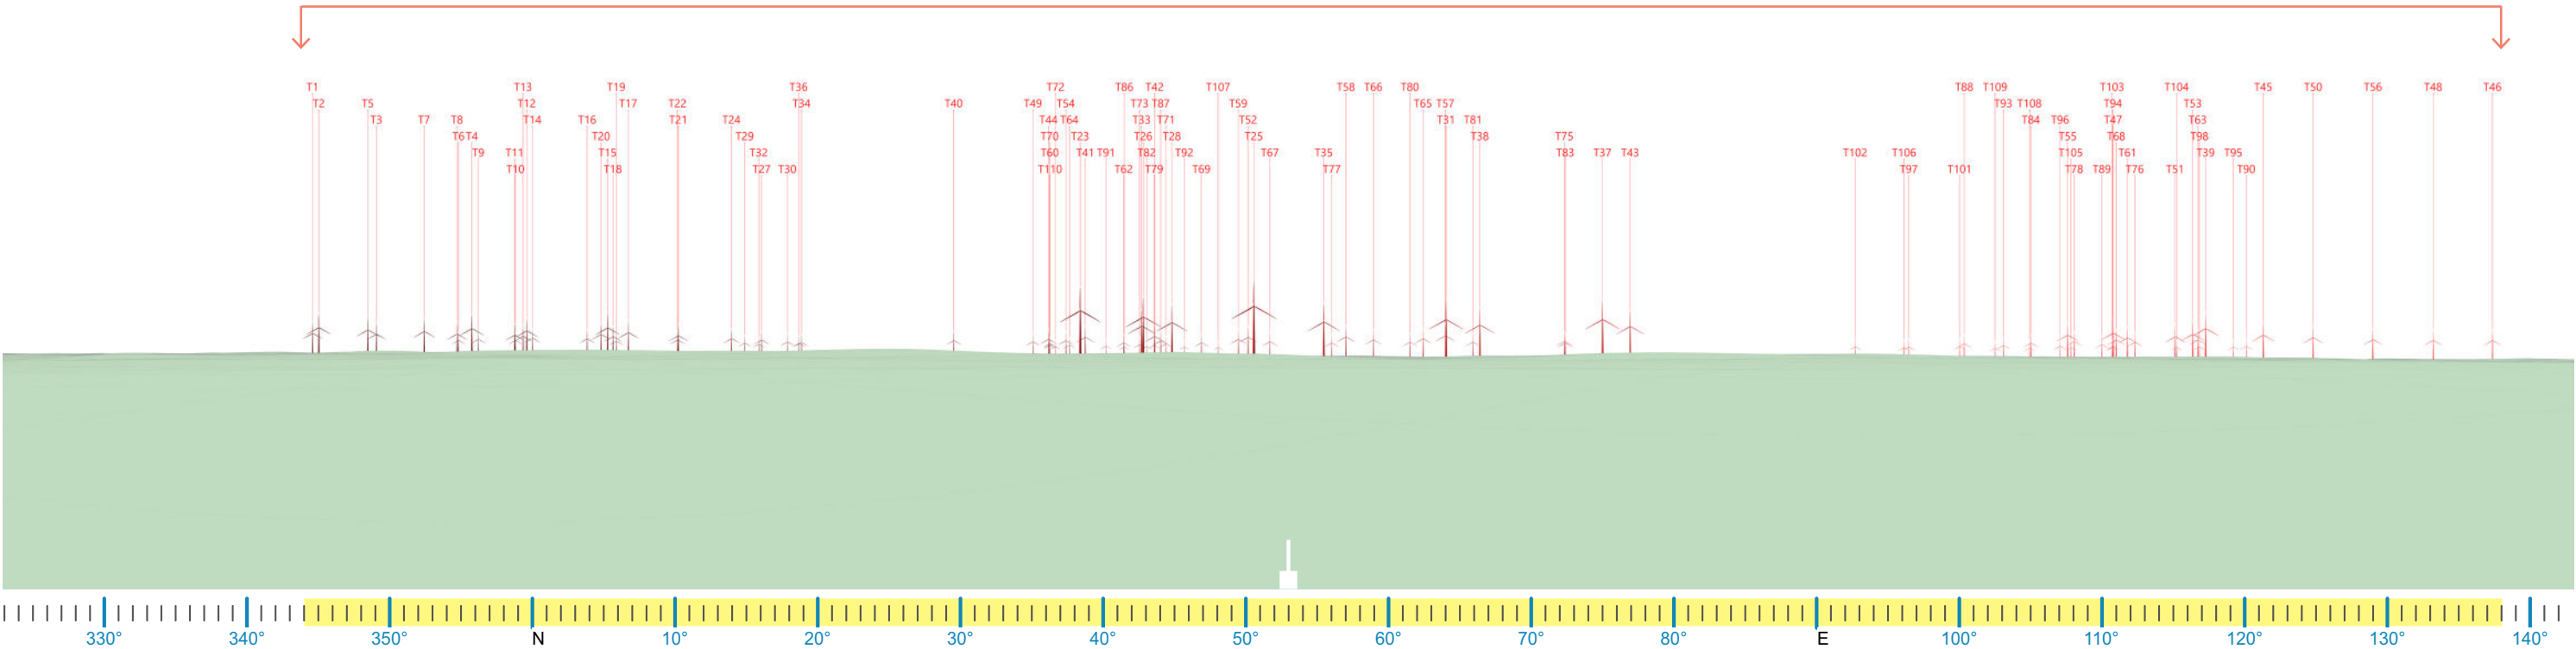
Proposed Wire Frame Diagram - 180 degree field of view

A wire frame diagram has been prepared for this assessment as access to the dwelling was not available. The wire frame diagram indicates all (106) turbines would theoretically be visible at hub height based on topography alone. The nearest turbine to the dwelling is located approximately 2.75 km away. Based on 3D assessment, views of the Project are theoretically available in the north, east and southeast. Aerial imagery indicates that the dwelling is surrounded by dense vegetation and farm outbuildings in the foreground in all directions. It is likely that existing vegetation and buildings will limit views to the Project. The visual impact resulting from the Project has been rated as **Low**.

Wire Frame Diagram indicates 106 turbines at hub height are visible.

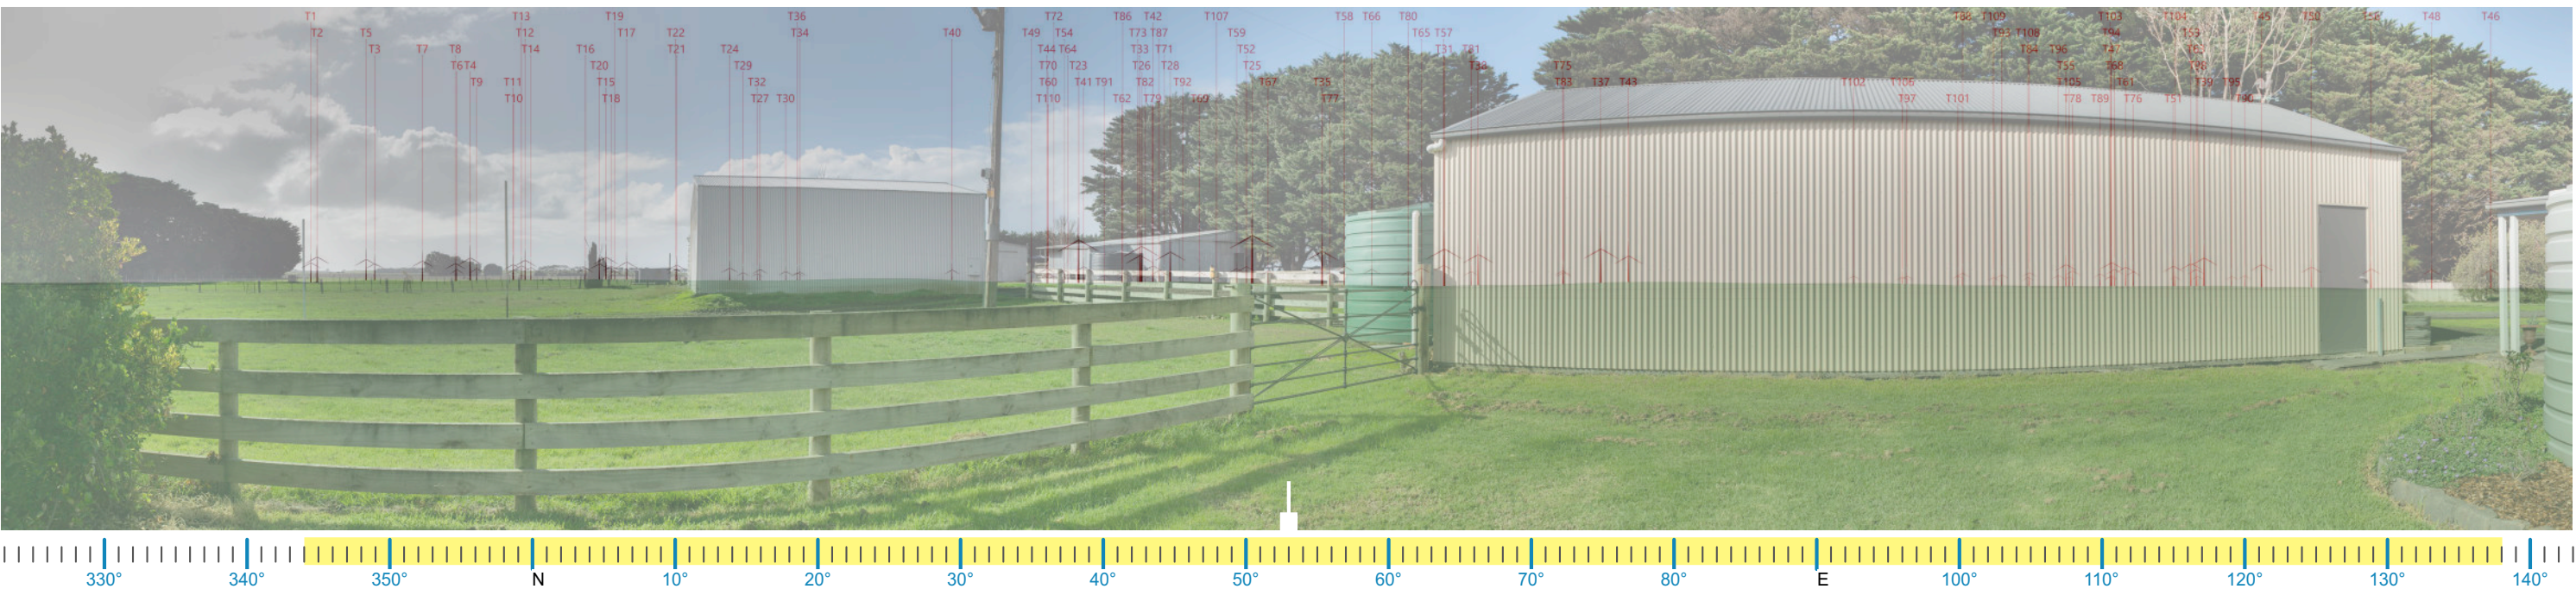
Existing View - 180 degree field of view

It is likely that majority of the turbines will be screened by existing vegetation and farm outbuildings. Mitigation is not required.

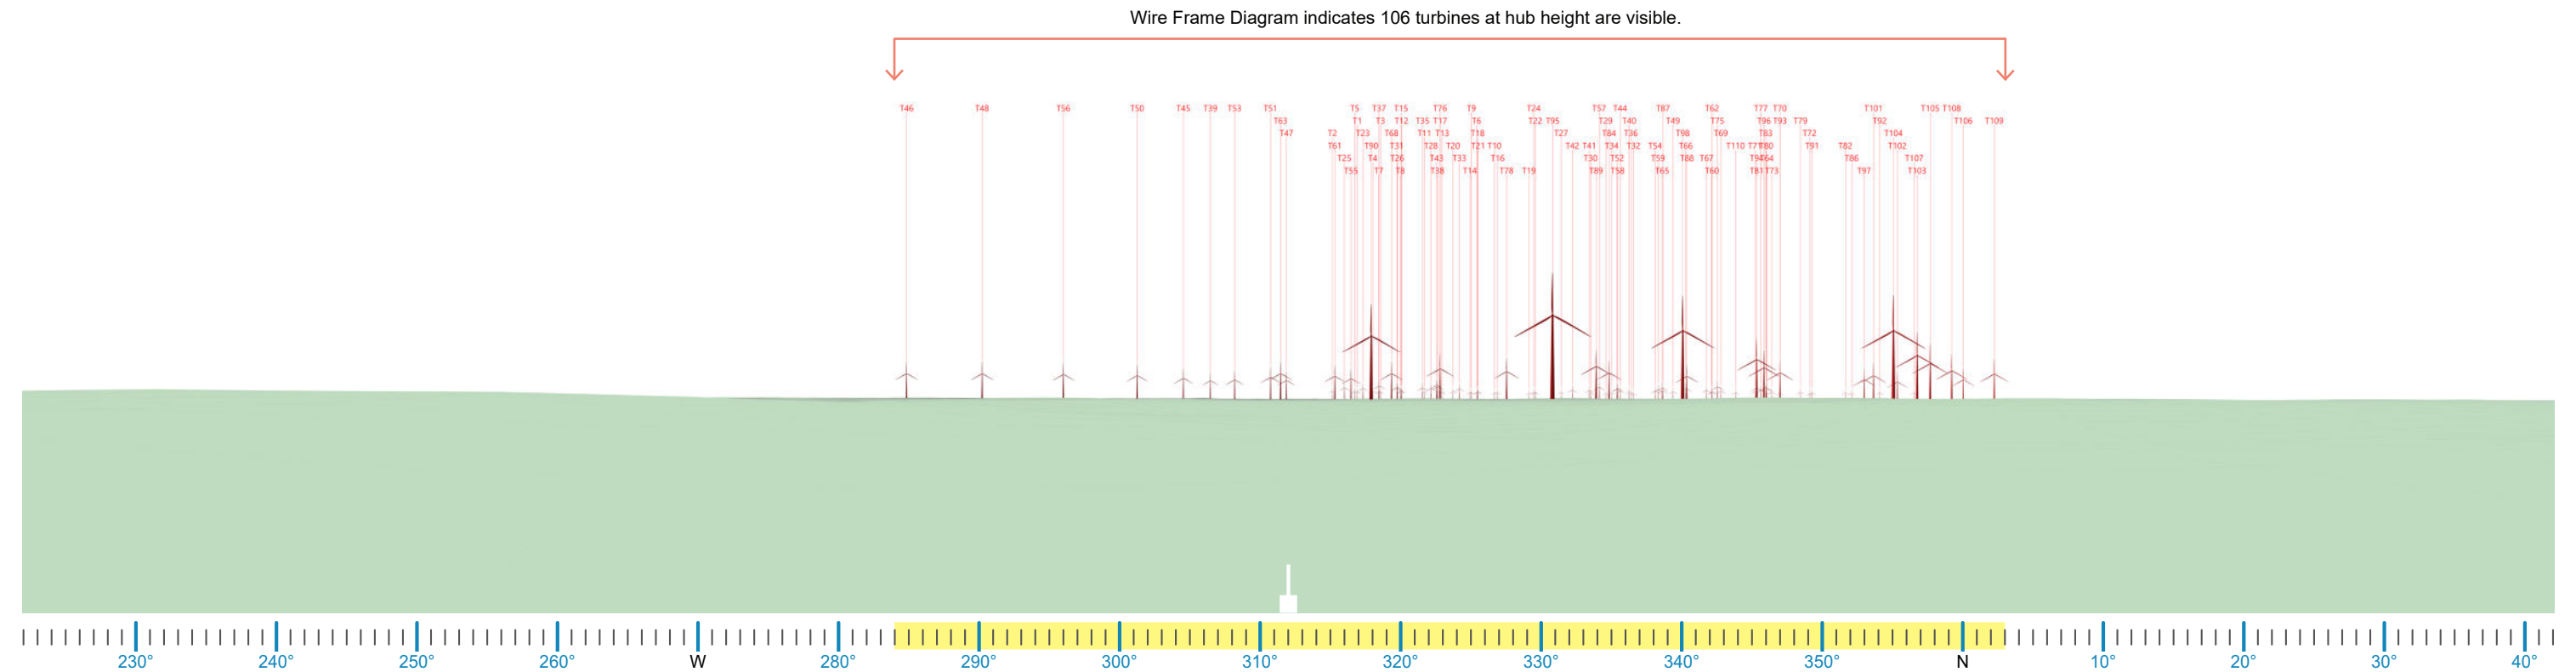
Proposed Wire Frame Diagram - 180 degree field of view

A site inspection was undertaken in May 2023 at this dwelling and a viewpoint was selected in consultation with the owner. The wire frame diagram prepared from the dwelling indicates all (106) turbines would theoretically be visible at hub height based on topography alone. The nearest turbine to the dwelling is located approximately 1.64 km away. On inspection it was determined that the dwelling is surrounded by vegetation and structures in the northwestern direction. Partial views of the closest turbines are likely to be available in up to 25 degrees of the viewshed. Views of all other turbines are likely to be screened by existing vegetation and farm outbuildings. It is likely that the Project will have a low impact on the scenic quality as the turbines will be either screened by vegetation or viewed in the context of farm outbuildings. Considering the extent of existing intervening elements in the dwelling's foreground, the visual impact resulting from the Project has been rated as **Low**.

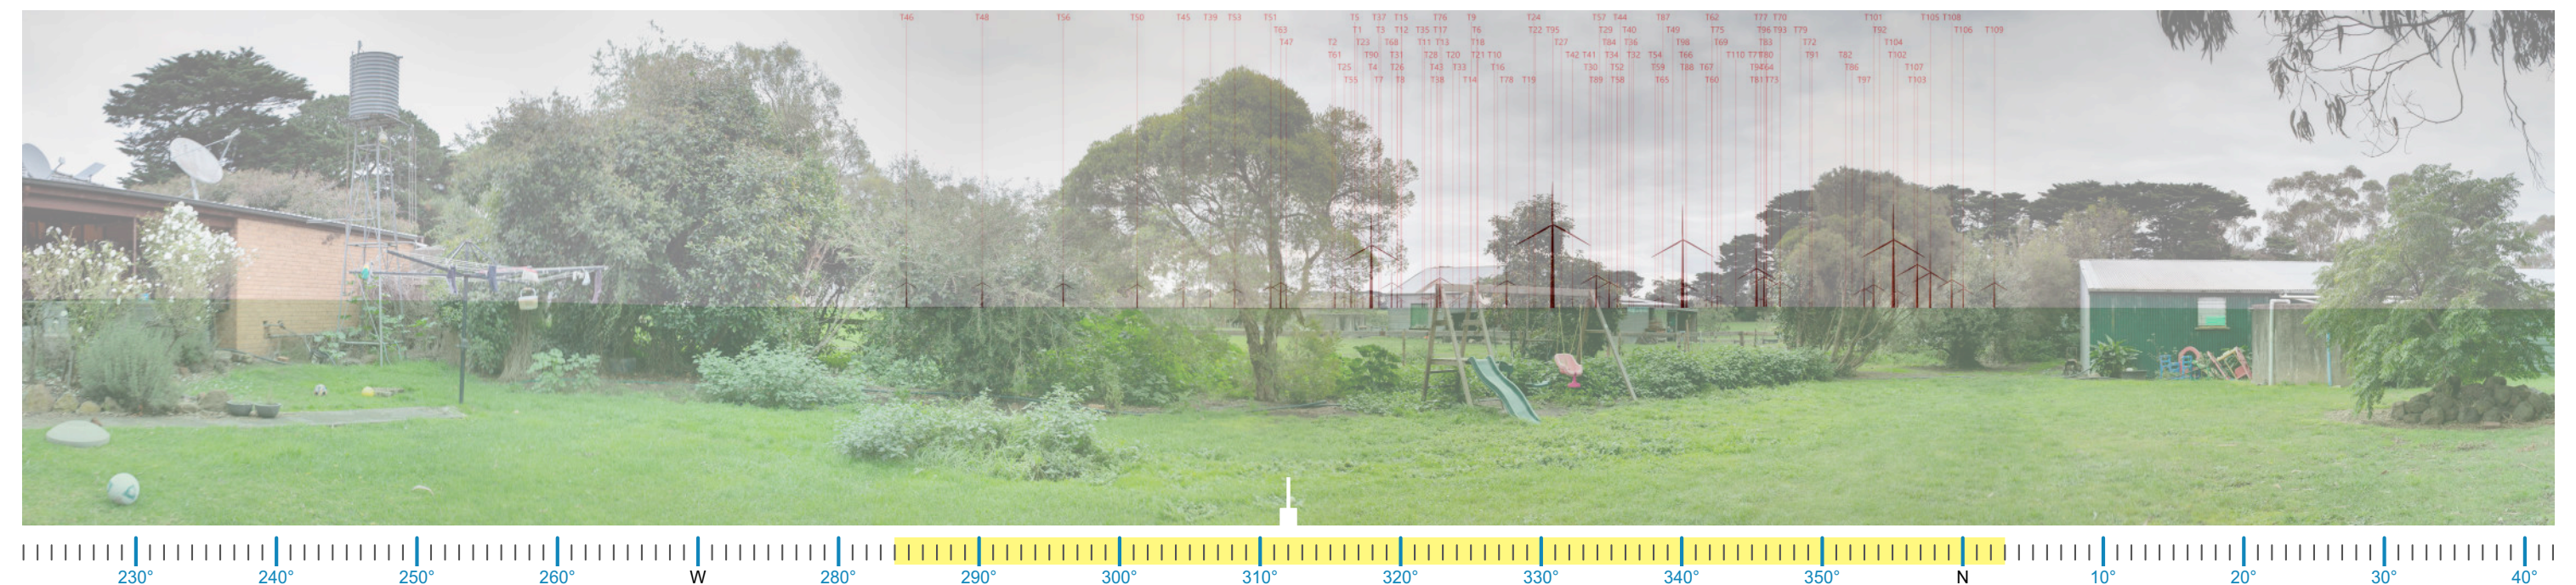
Existing View - 180 degree field of view

It is likely that majority of the turbines will be screened by existing vegetation. Mitigation is not required.

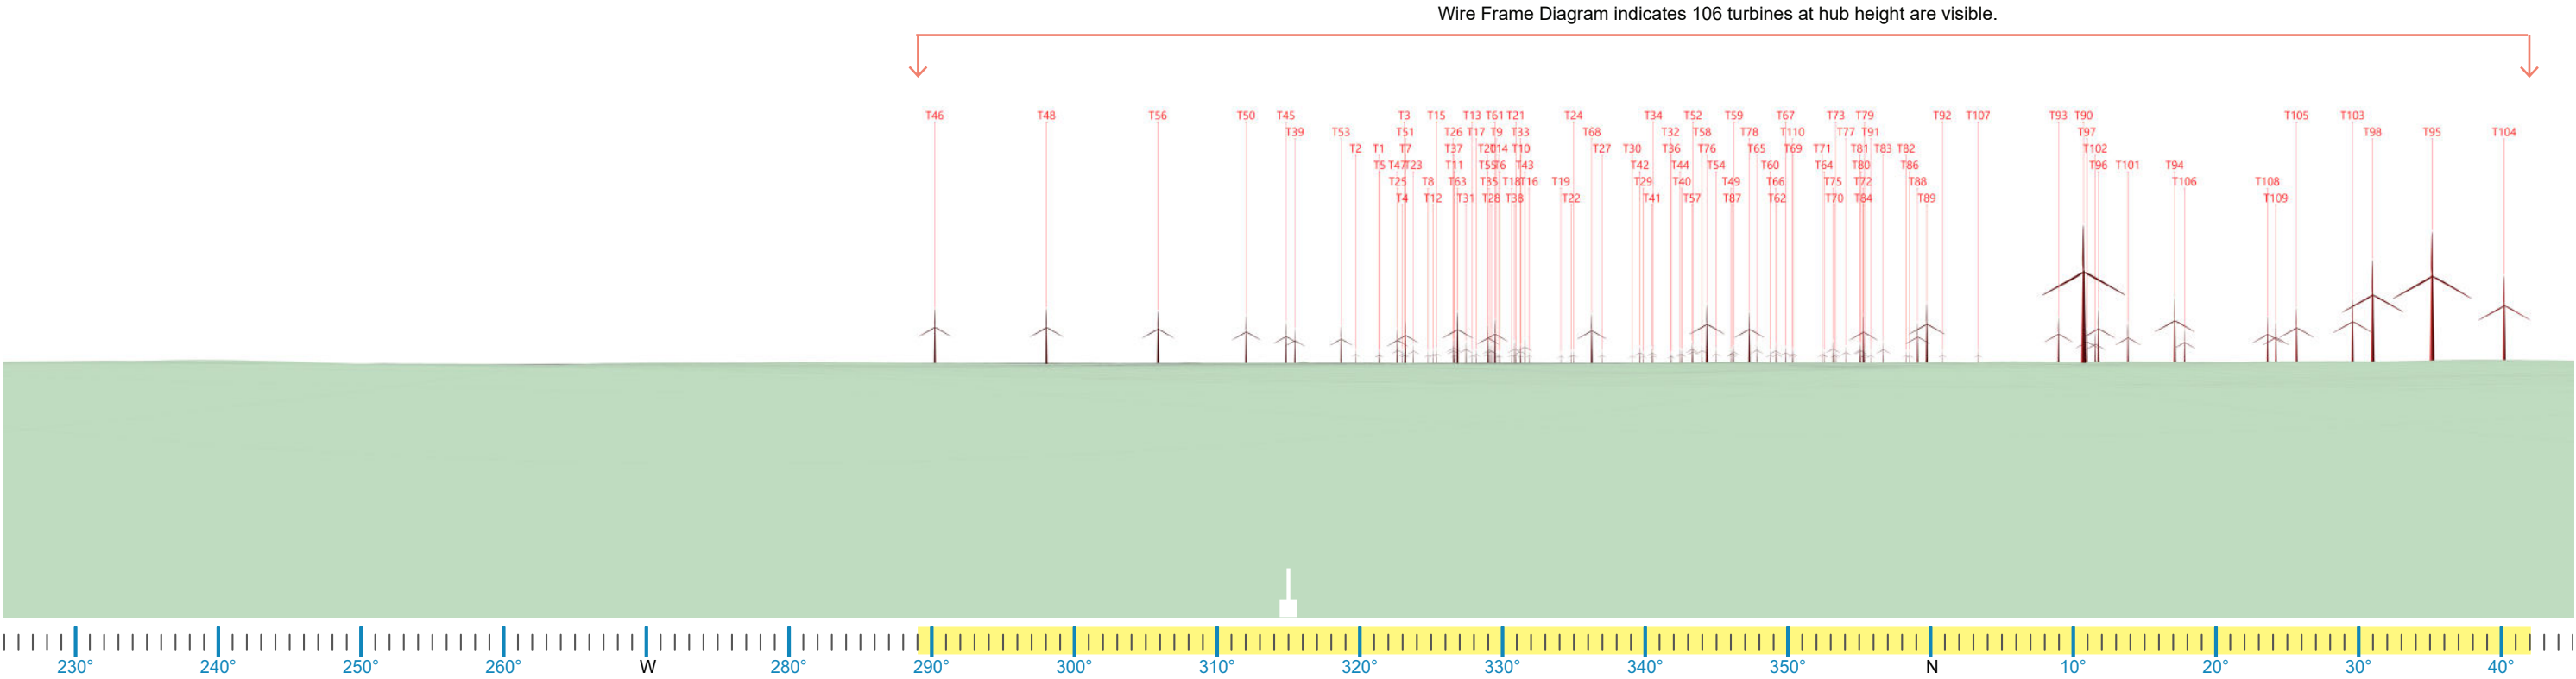
Proposed Wire Frame Diagram - 180 degree field of view

A wire frame diagram has been prepared for this assessment as access to the dwelling was not available. The wire frame diagram indicates all (106) turbines would theoretically be visible at hub height based on topography alone. The nearest turbine to the dwelling is located approximately 1.53 km away. Based on 3D assessment, views of the Project are likely to be available in the northwest. Aerial imagery indicates that the dwelling is surrounded by scattered vegetation and dense windbreak vegetation along Gordons Lane. The vegetation and farm outbuildings will screen views to most, if not all of the turbines. Based on desktop assessment, the visual impact resulting from the Project has been rated as **Low**.

Note:
No access to Site was available.
The wire frame diagram is a preliminary assessment tool that represents a bare ground scenario - ie. a landscape without screening, structures or vegetation. As accurate information on the height and coverage of vegetation and buildings is unavailable, it is important to note the wire frame diagram is based solely on topographic information.
Therefore this should be acknowledged as representing the absolute worst case scenario.

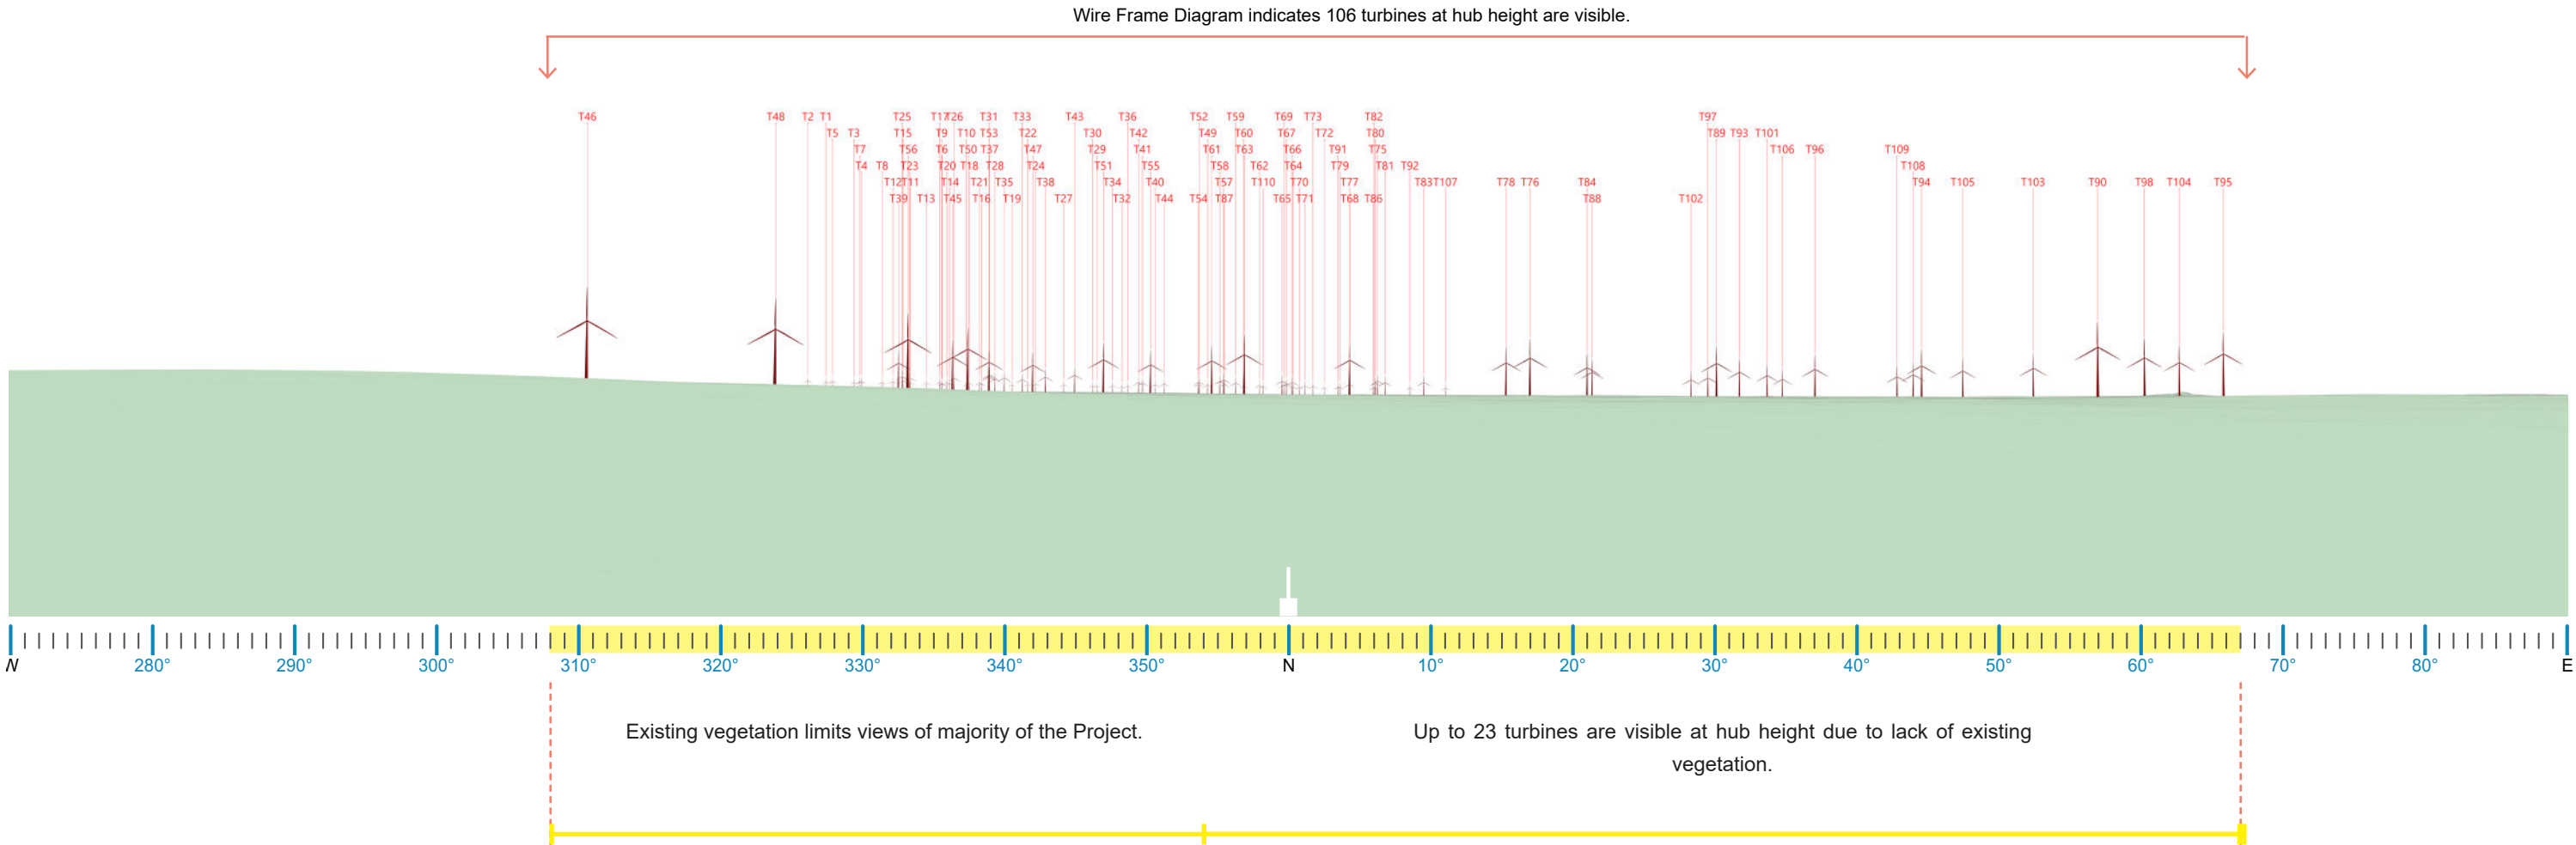
Proposed Wire Frame Diagram - 180 degree field of view

A site inspection was undertaken in May 2023 at this dwelling. The wire frame diagram prepared from the dwelling indicates 106 turbines would theoretically be visible at hub height based on topography alone. The nearest turbine to the dwelling is located approximately 2.09 km away. On inspection it was determined that views towards the project will be screened by vegetation to the north of the dwelling. Fragmented views towards the project will be available from the north eastern corner of the house paddock. A photomontage has been prepared to demonstrate the extent of potential visibility of the turbines from this location. Up to 23 turbines are likely to be visible in up to 60 degrees of the viewshed to the northeast. It is likely that the Project will have minimal impact on the scenic quality of the view from this dwelling. The visual impact resulting from the Project has been rated as **Low**.

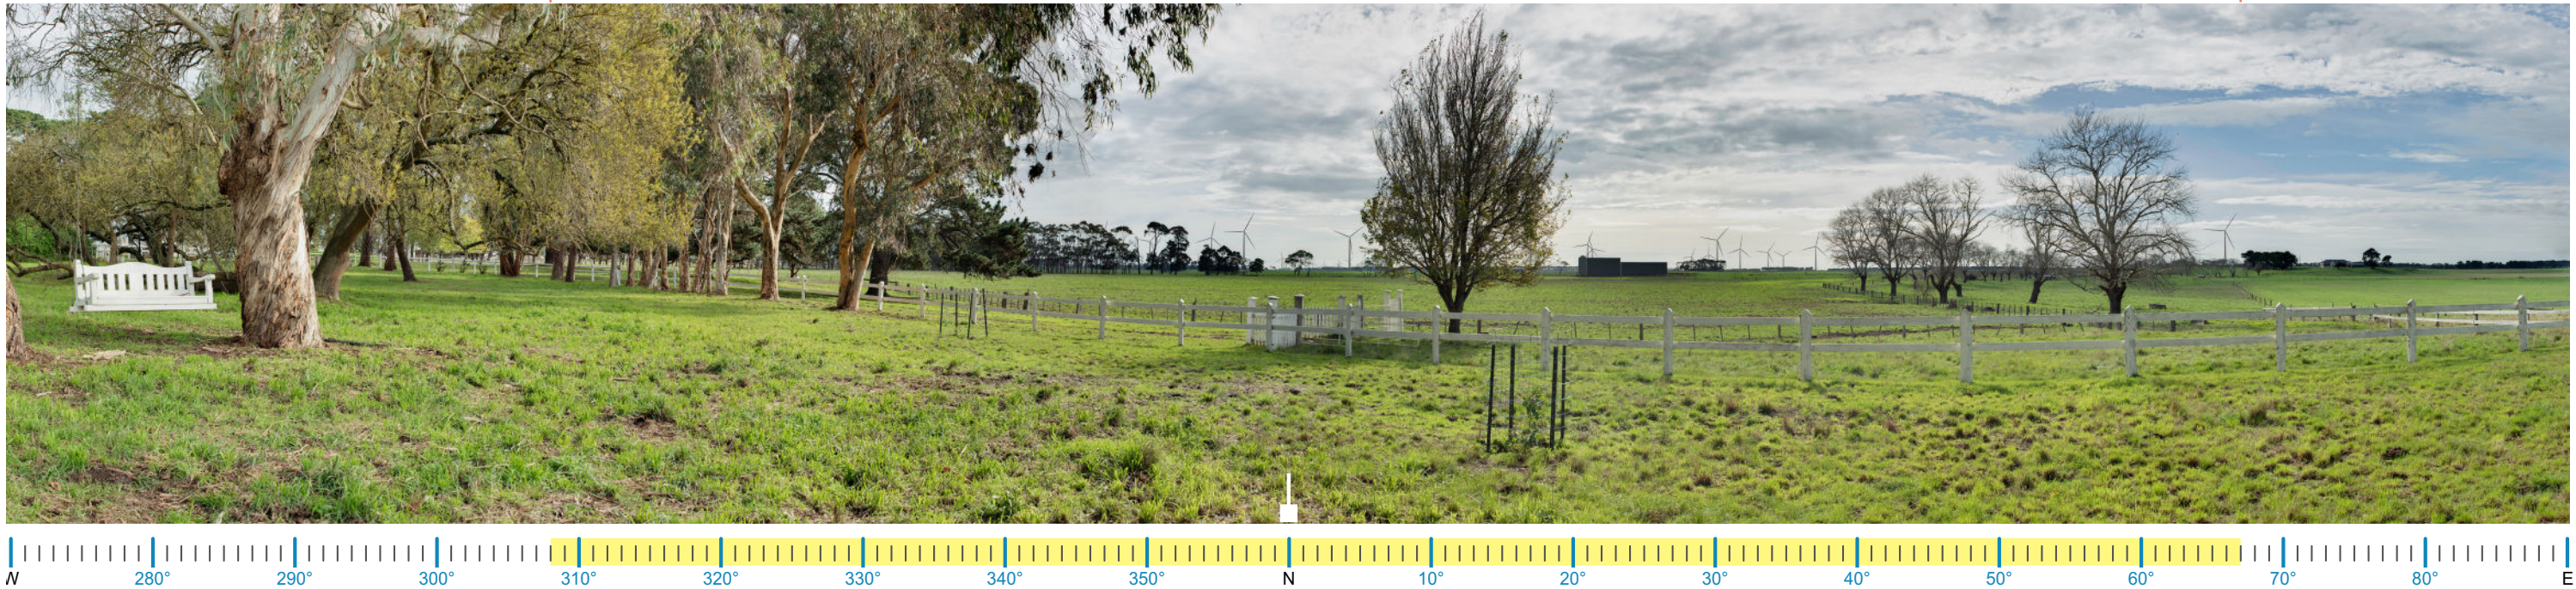
Proposed View - 180 degree field of view

Viewpoint was selected in consultation with the landowner.
