A.13. Dwelling Assessment Dwelling D341

DWELLING D341			
Nearest proposed turbine (km):	1.66 km	Viewer Sensitivity:	Moderate
Number of proposed turbines within 6,000m of the dwelling:	18	Scenic Quality Rating:	Low
Number of potentially visible turbines (Based on topography alone)	106	Landscape Character Unit:	LCU01

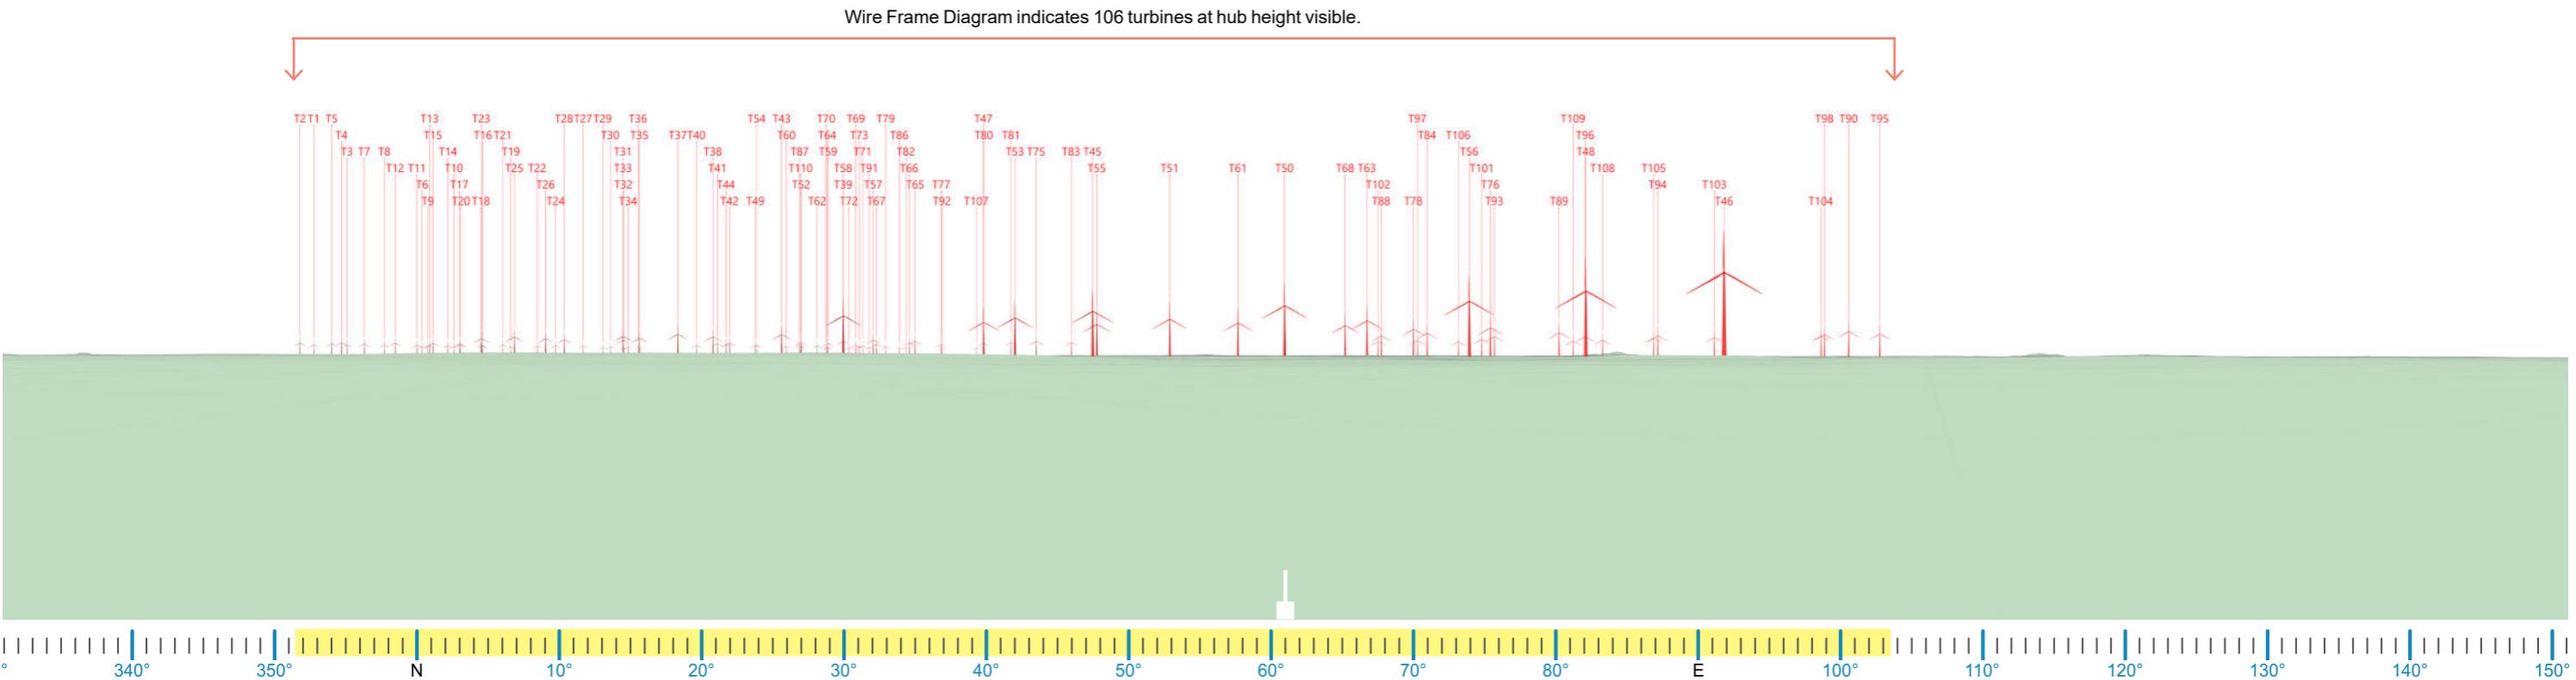
Proposed Wire Frame Diagram - 180 degree field of view

A site inspection was undertaken in May 2023 at this dwelling and a viewpoint was selected in consultation with the owner. The wire frame diagram prepared from the dwelling indicates all (106) turbines would theoretically be visible at hub height based on topography alone. The nearest turbine to the dwelling is located approximately 1.66 km away. On inspection it was found that the dwelling is surrounded by dense windbreak vegetation along the northern boundary. Views to the north and northeast are screened by existing windbreak vegetation. Up to one (1) blade tips are likely to be visible at this dwelling and it is likely that the Project will have a low impact on the existing scenic quality. The visual impact resulting from the Project has been rated as **Low**.

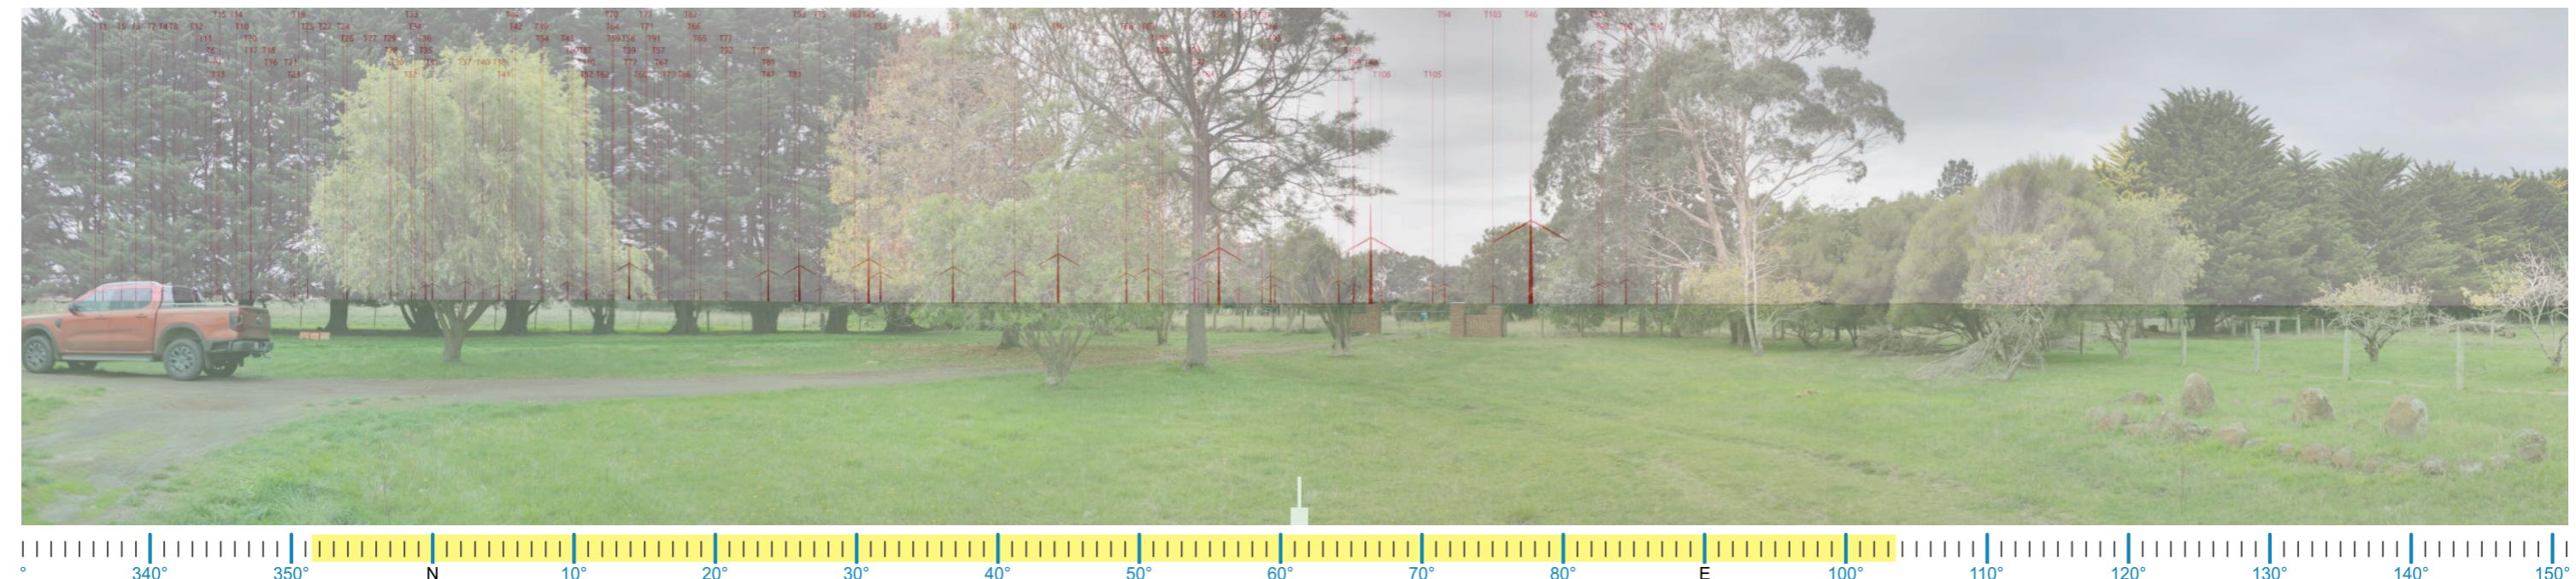
Existing View - 180 degree field of view

Existing vegetation will screen view to the turbines. Mitigation is not required.

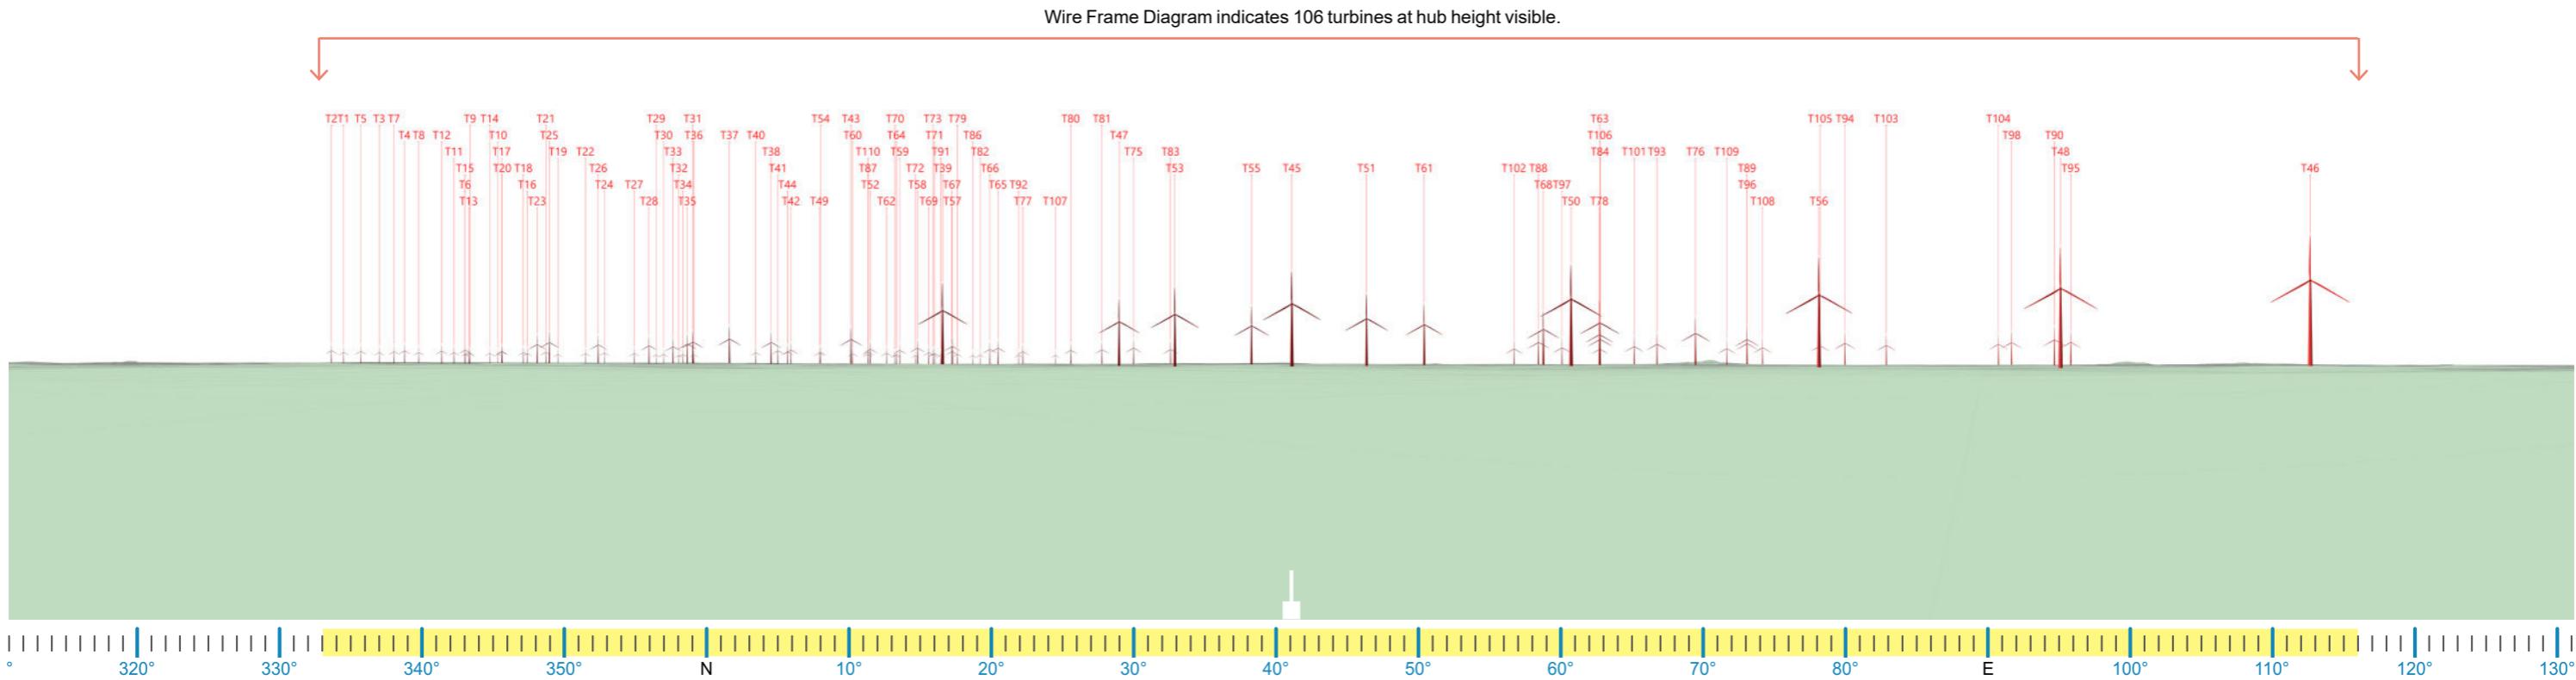
Proposed Wire Frame Diagram - 180 degree field of view

The wire frame diagram is a preliminary assessment tool that represents a bare ground scenario - ie. a landscape without screening, structures or vegetation. As accurate information on the height and coverage of vegetation and buildings is unavailable, it is important to note the wire frame diagram is based solely on topographic information.

Therefore this should be acknowledged as representing the absolute worst case scenario.

DWELLING D345			
Nearest proposed turbine (km):	1.60 km	Viewer Sensitivity:	Moderate
Number of proposed turbines within 6,000m of the dwelling:	21	Scenic Quality Rating:	Low
Number of potentially visible turbines (Based on topography alone)	106	Landscape Character Unit:	LCU01
Visual Impact Rating: Low			
Assessment Notes: A wire frame diagram has been prepared for this assessment as access to the dwelling was not available. The wire frame diagram prepared from the dwelling indicates all (106) turbines would theoretically be visible at hub height based on topography alone. The nearest turbine to the dwelling is located approximately 1.60 km away. Based on 3D assessment, views of the Project are likely to be available in the northeast. Aerial imagery indicates that the dwelling is surrounded by rows of dense windbreak vegetation along the northern and eastern boundaries of the lot. Additional dense vegetation lines Grassmere-Hexham Road between the dwelling and the project. It is likely that existing vegetation would screen views to the project. Based on desktop assessment, the visual impact resulting from the Project has been rated as Low .

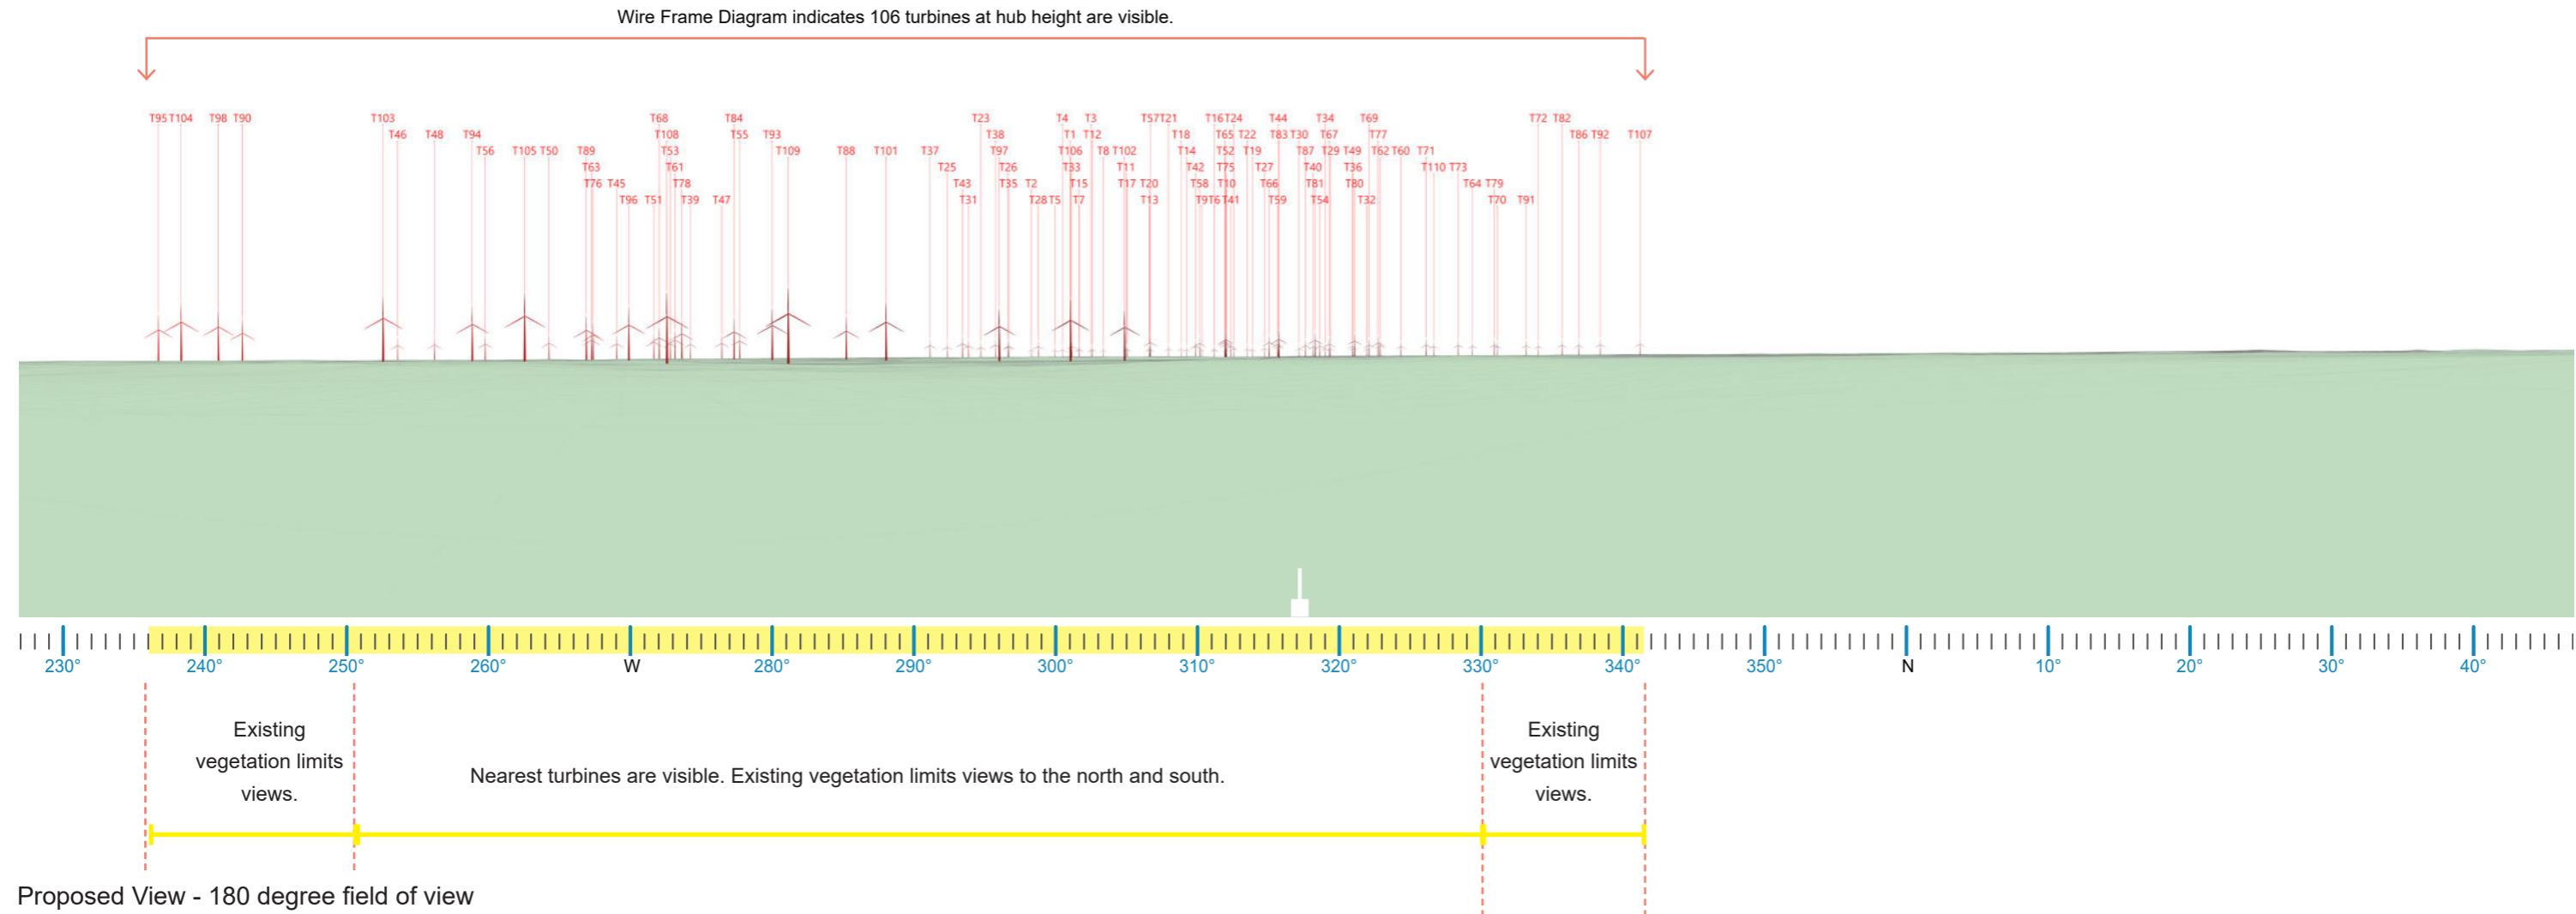
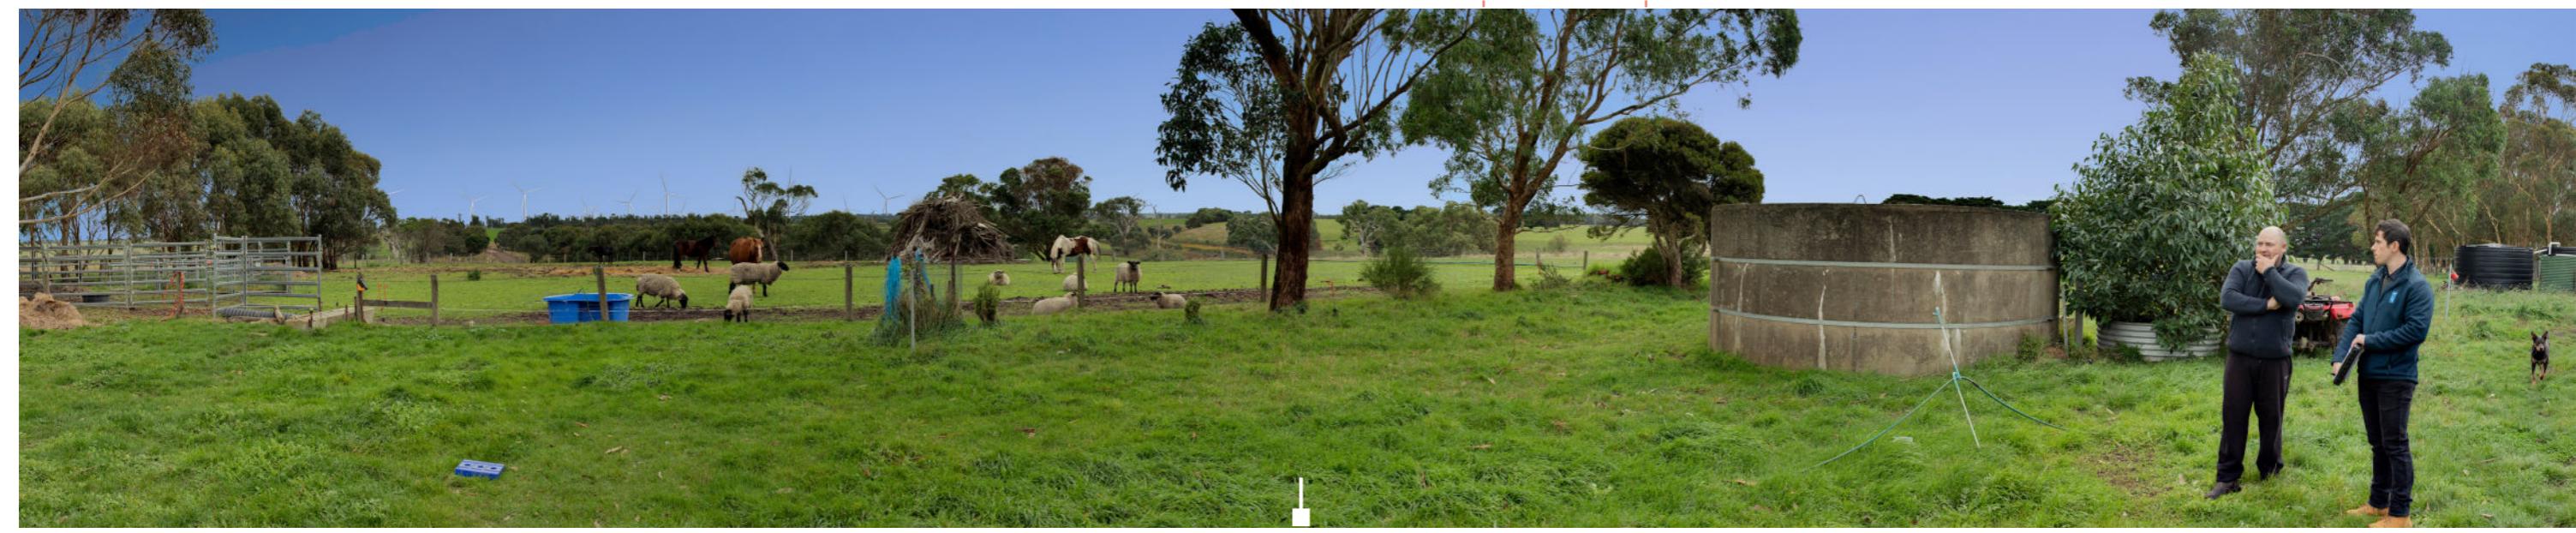
Proposed Wire Frame Diagram - 180 degree field of view

A site inspection was undertaken in May 2023 at this dwelling and a viewpoint was selected in consultation with the owner. The wire frame diagram prepared from the dwelling indicates 106 turbines would be theoretically visible at hub height based on topography alone. The nearest turbine is located approximately 2.77 km away from the dwelling. On inspection it was determined that the dwelling is surrounded by scattered vegetation to the north and west. A photomontage has been prepared to demonstrate the extent of visibility of the Project from the dwelling. Gaps in the existing vegetation allow visibility of the nearest and turbines in up to 80 degrees of the viewshed. It is likely that the turbines will have a moderate impact on the existing scenic quality of the view from this dwelling. The visual impact resulting from the Project has been rated as **Moderate**.

Supplementary screen planting along the existing row of windbreak vegetation would potentially reduce the visual impact to low as demonstrated in locations where existing windbreak planting is effective in screening views, however this will take time to establish. Consultation with the landowner is recommended to discuss appropriate mitigation options.

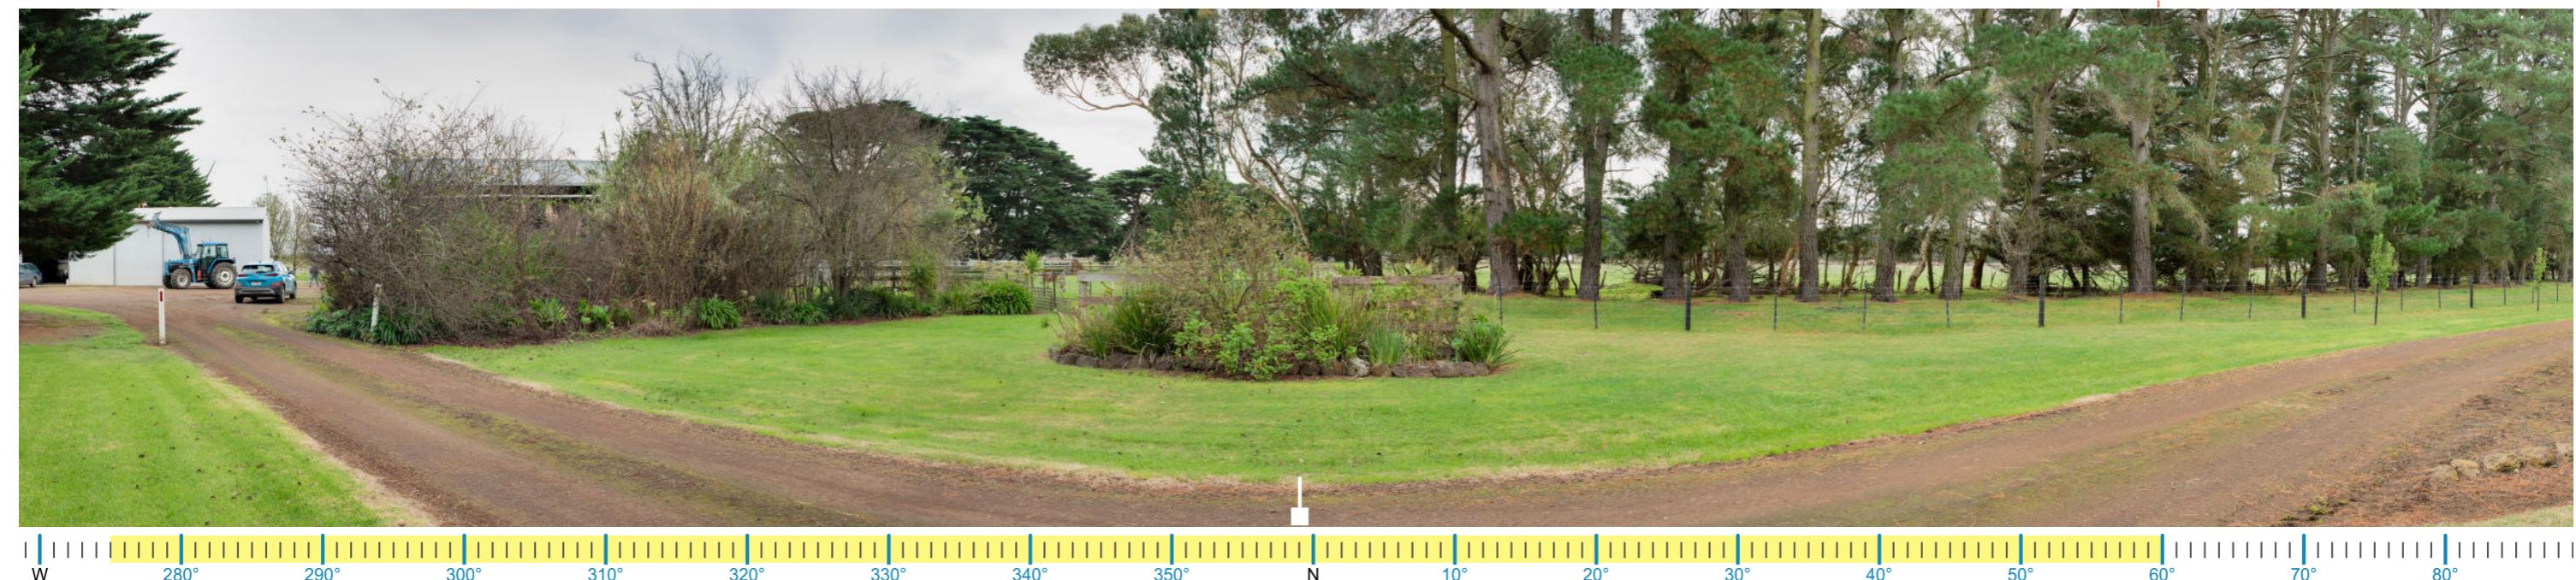
Proposed View 1 - 180 degree field of view

Existing vegetation will screen view to majority of the turbines. Mitigation is not required.

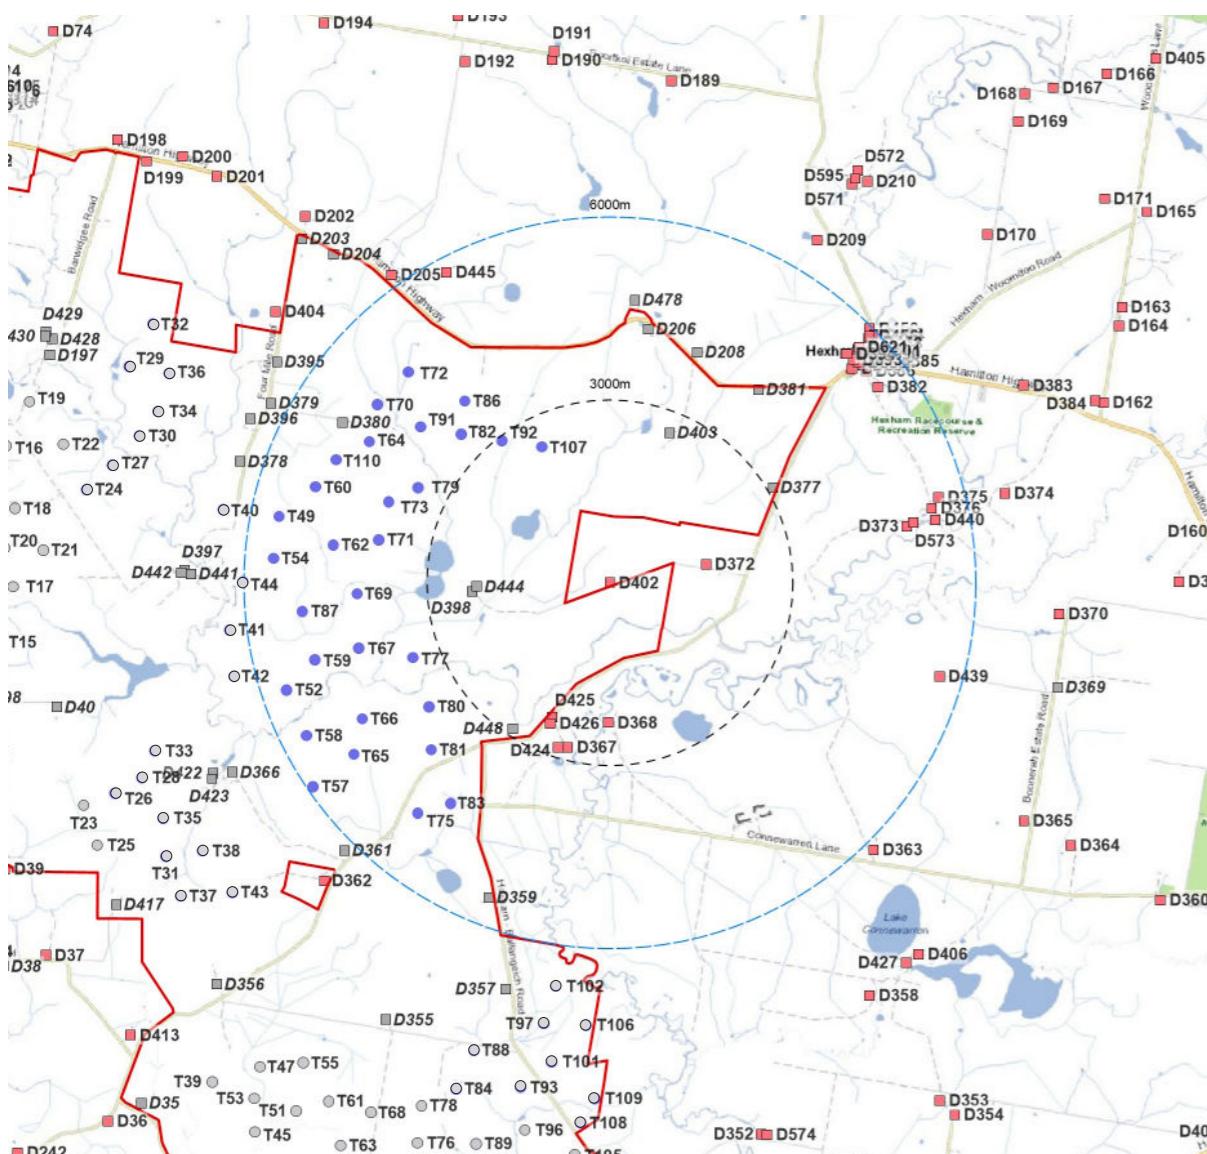
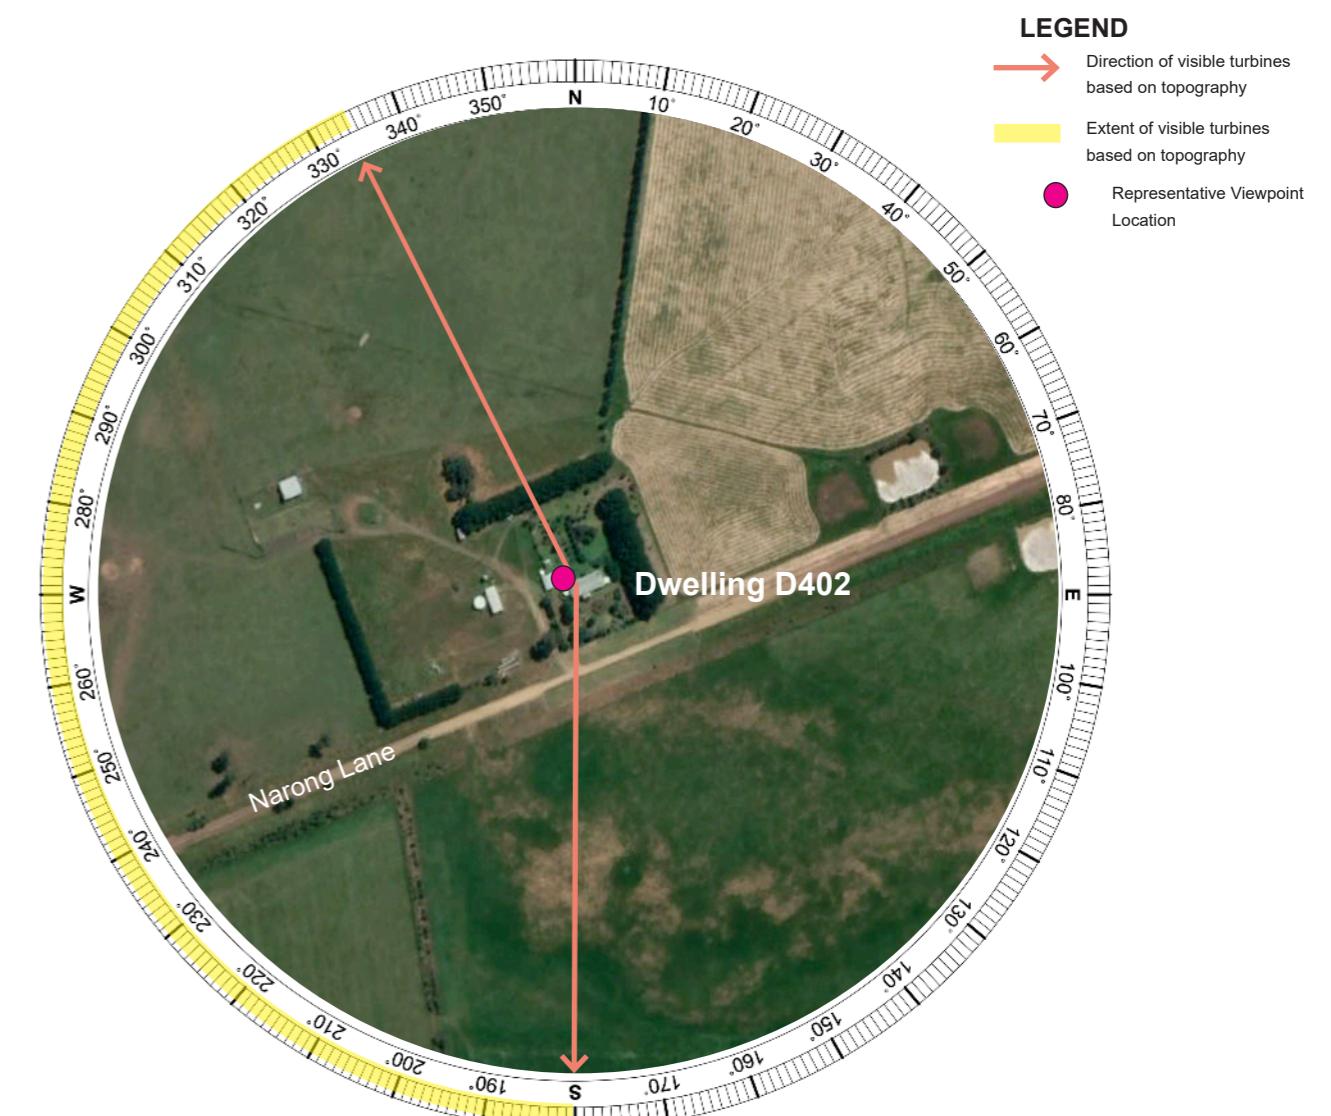
A site inspection was undertaken in May 2023 at this dwelling and a viewpoint was selected in consultation with the owner. The wire frame diagram prepared from the dwelling indicates all (106) turbines would theoretically be visible at hub height based on topography alone. The nearest turbine is located approximately 2.50 km away from the dwelling in the westerly direction. On inspection it was determined that the dwelling is surrounded by dense windbreak vegetation and farm outbuildings on the western side of the dwelling. It is likely that up to four (4) blade tips will be partially visible in up to 15 degrees of the viewshed. The majority of the turbines will be screened by existing vegetation and farm outbuildings. It is likely that the Project will have low impact on the existing scenic quality. The visual impact resulting from the Project has been rated as **Low**.

- Turbine within 6,000 m (Based on Wire Frame Diagram)
- Turbine out of 6,000 m (Based on Wire Frame Diagram)
- Non-involved Dwelling
- Involved Dwelling
- 3,000 m from nearest turbine
- 6,000 m from nearest turbine

Existing vegetation will screen view to the turbines. Mitigation is not required.
