A.23. Dwelling Assessment Dwelling D622

A.24. Dwelling Assessment Dwelling D424

A.25. Dwelling Assessment Dwelling D367

A.26. Dwelling Assessment Dwelling D425

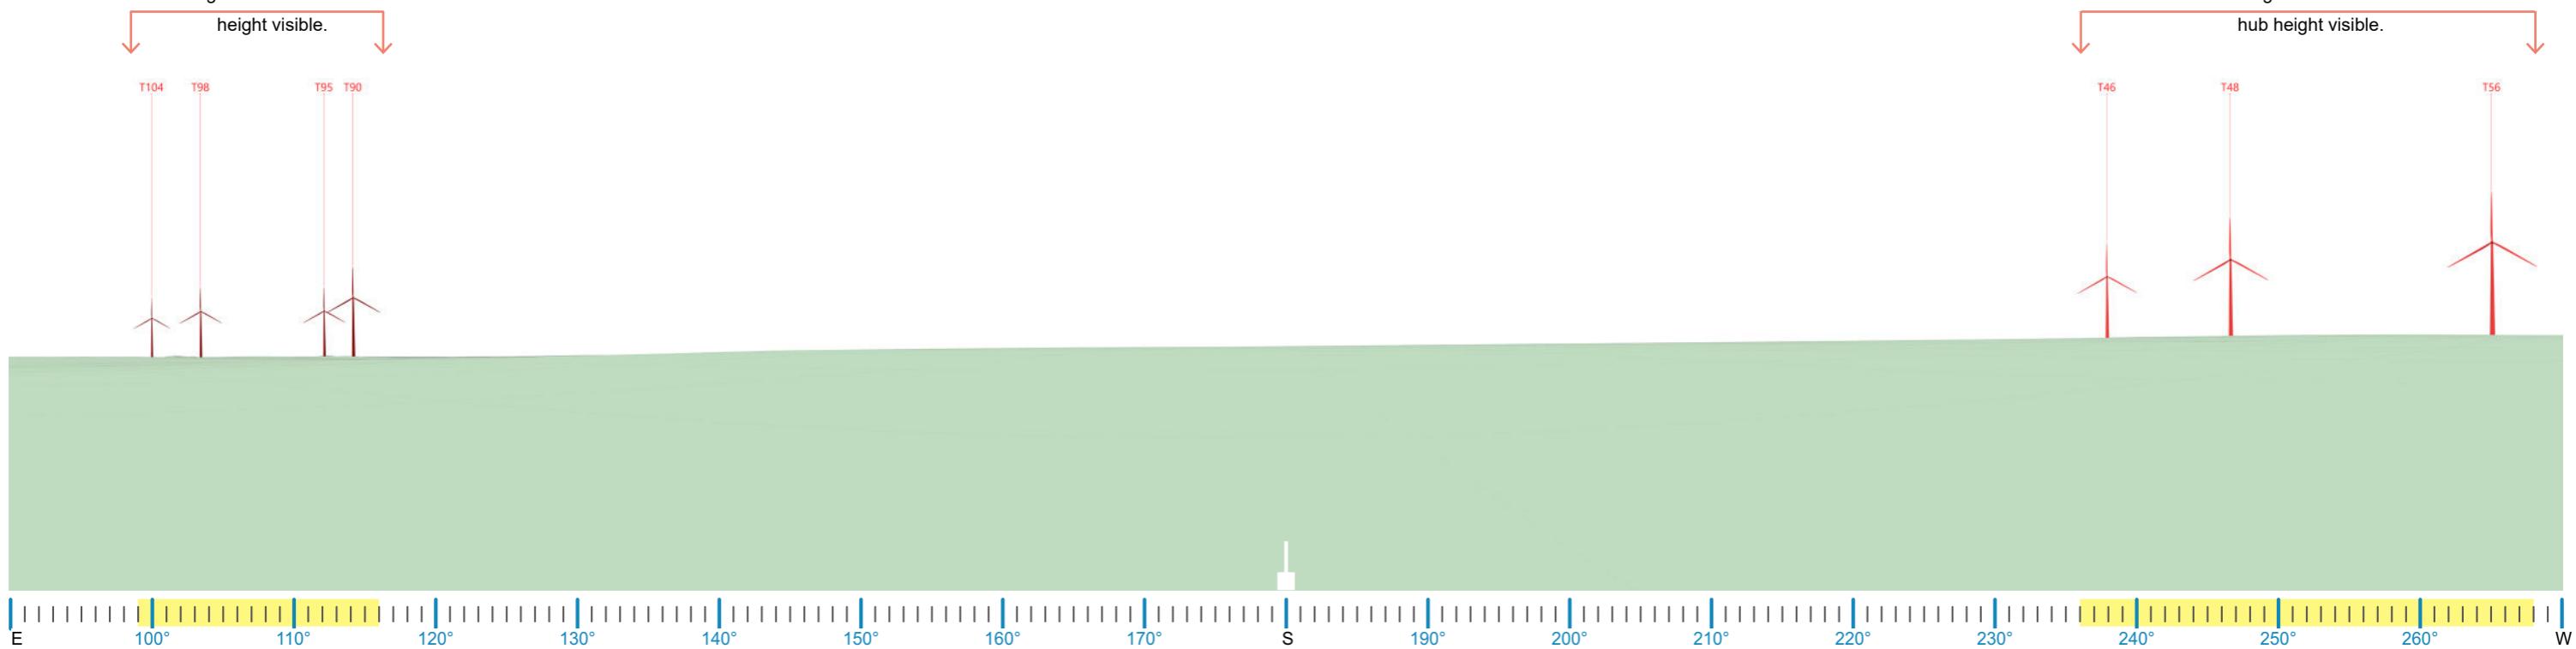
Proposed Wire Frame Diagram - 180 degree field of view

Wire Frame Diagram indicates 4 turbines at hub

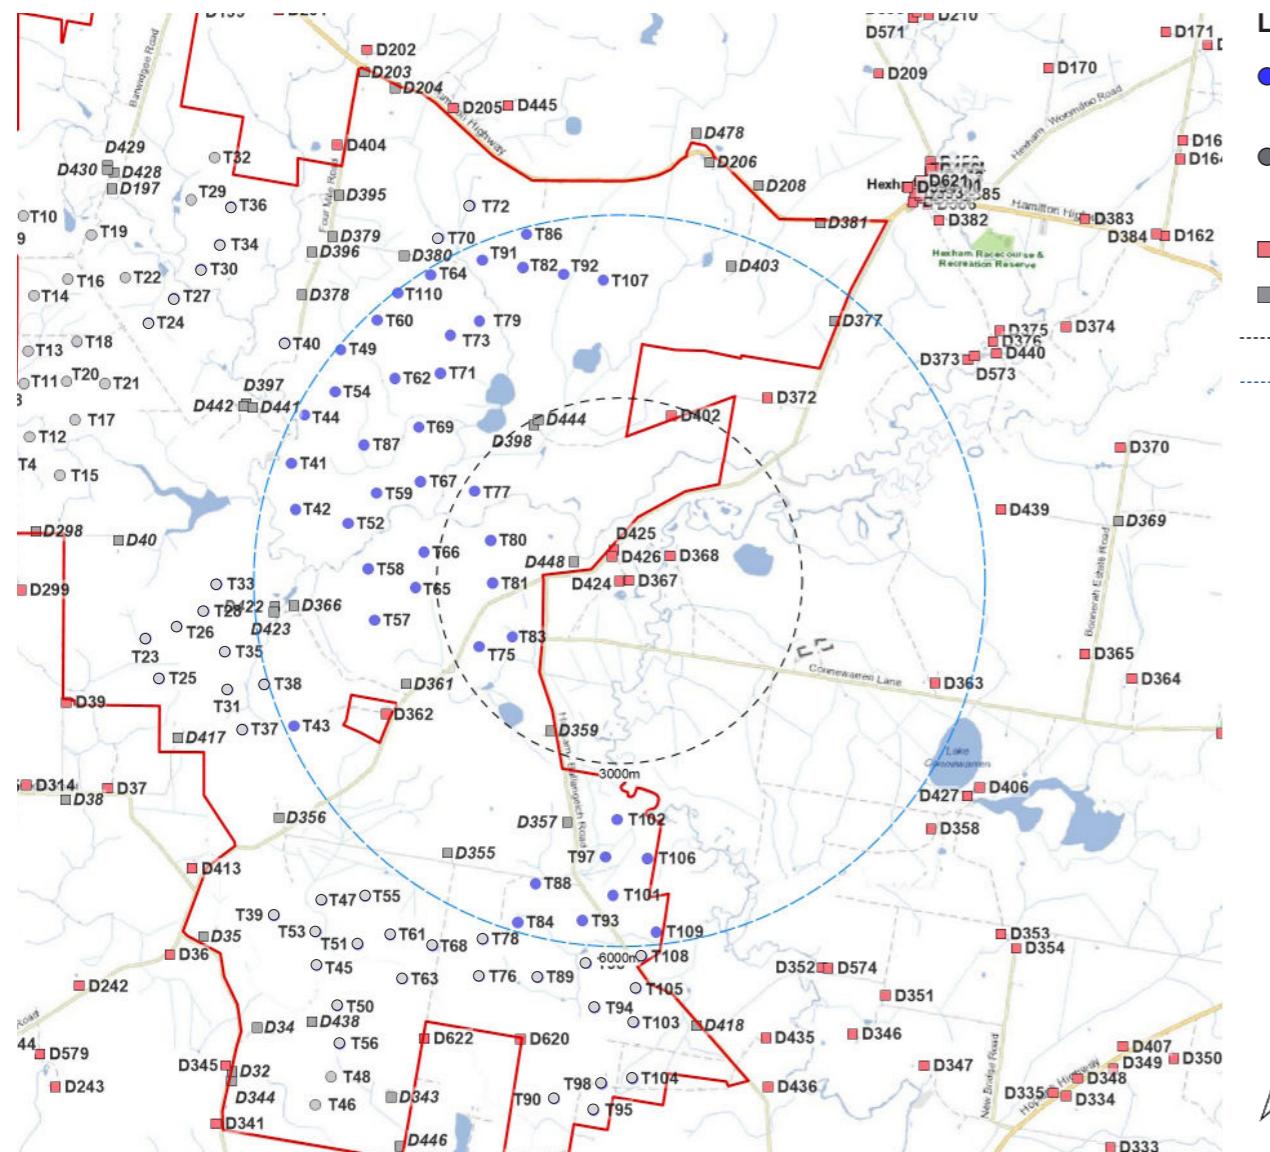
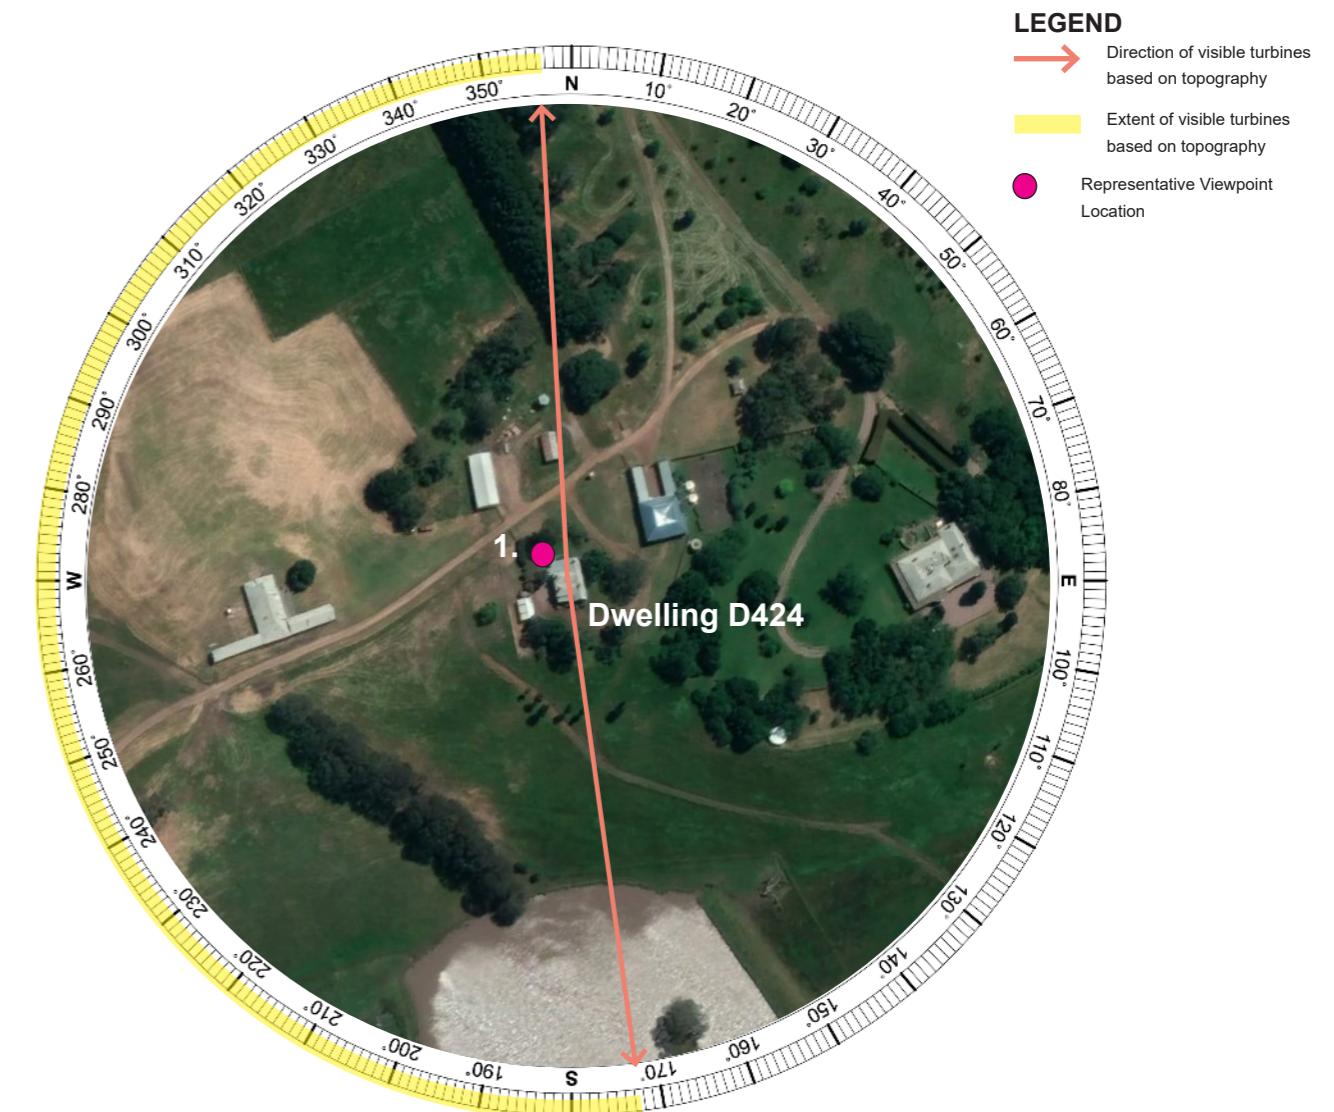
DWELLING D424

Nearest proposed turbine (km):	1.99 km	Viewer Sensitivity:	Moderate
Number of proposed turbines within 6,000m of the dwelling:	40	Scenic Quality Rating:	Low
Number of potentially visible turbines (Based on topography alone)	106	Landscape Character Unit:	LCU01

Visual Impact Rating: Low

A site inspection was undertaken in July 2023 at this dwelling and a viewpoint was selected in consultation with the owner. The wire frame diagram prepared from the dwelling indicates all (106) turbines would theoretically be visible at hub height based on topography alone. The nearest turbine is located approximately 1.99 km away to the southwest of the dwelling. On inspection it was found that the dwelling is surrounded by scattered vegetation in the foreground, farm outbuildings to the north and northwest and dense windbreak vegetation further to the north, northwest and southwest. A photomontage has been prepared to demonstrate the extent of visibility of the Project from the dwelling. Gaps in existing vegetation allow partial visibility of the nearest turbines in up to 15 degrees of the viewshed in the western direction. It is likely that the Project will have a low impact on the scenic quality due to its limited visibility from the dwelling. It is likely that the Project will have a minimal impact on the scenic quality. The visual impact resulting from the Project has been rated as **Low**.

Existing vegetation will assist in screening view to the turbines. No mitigation required.

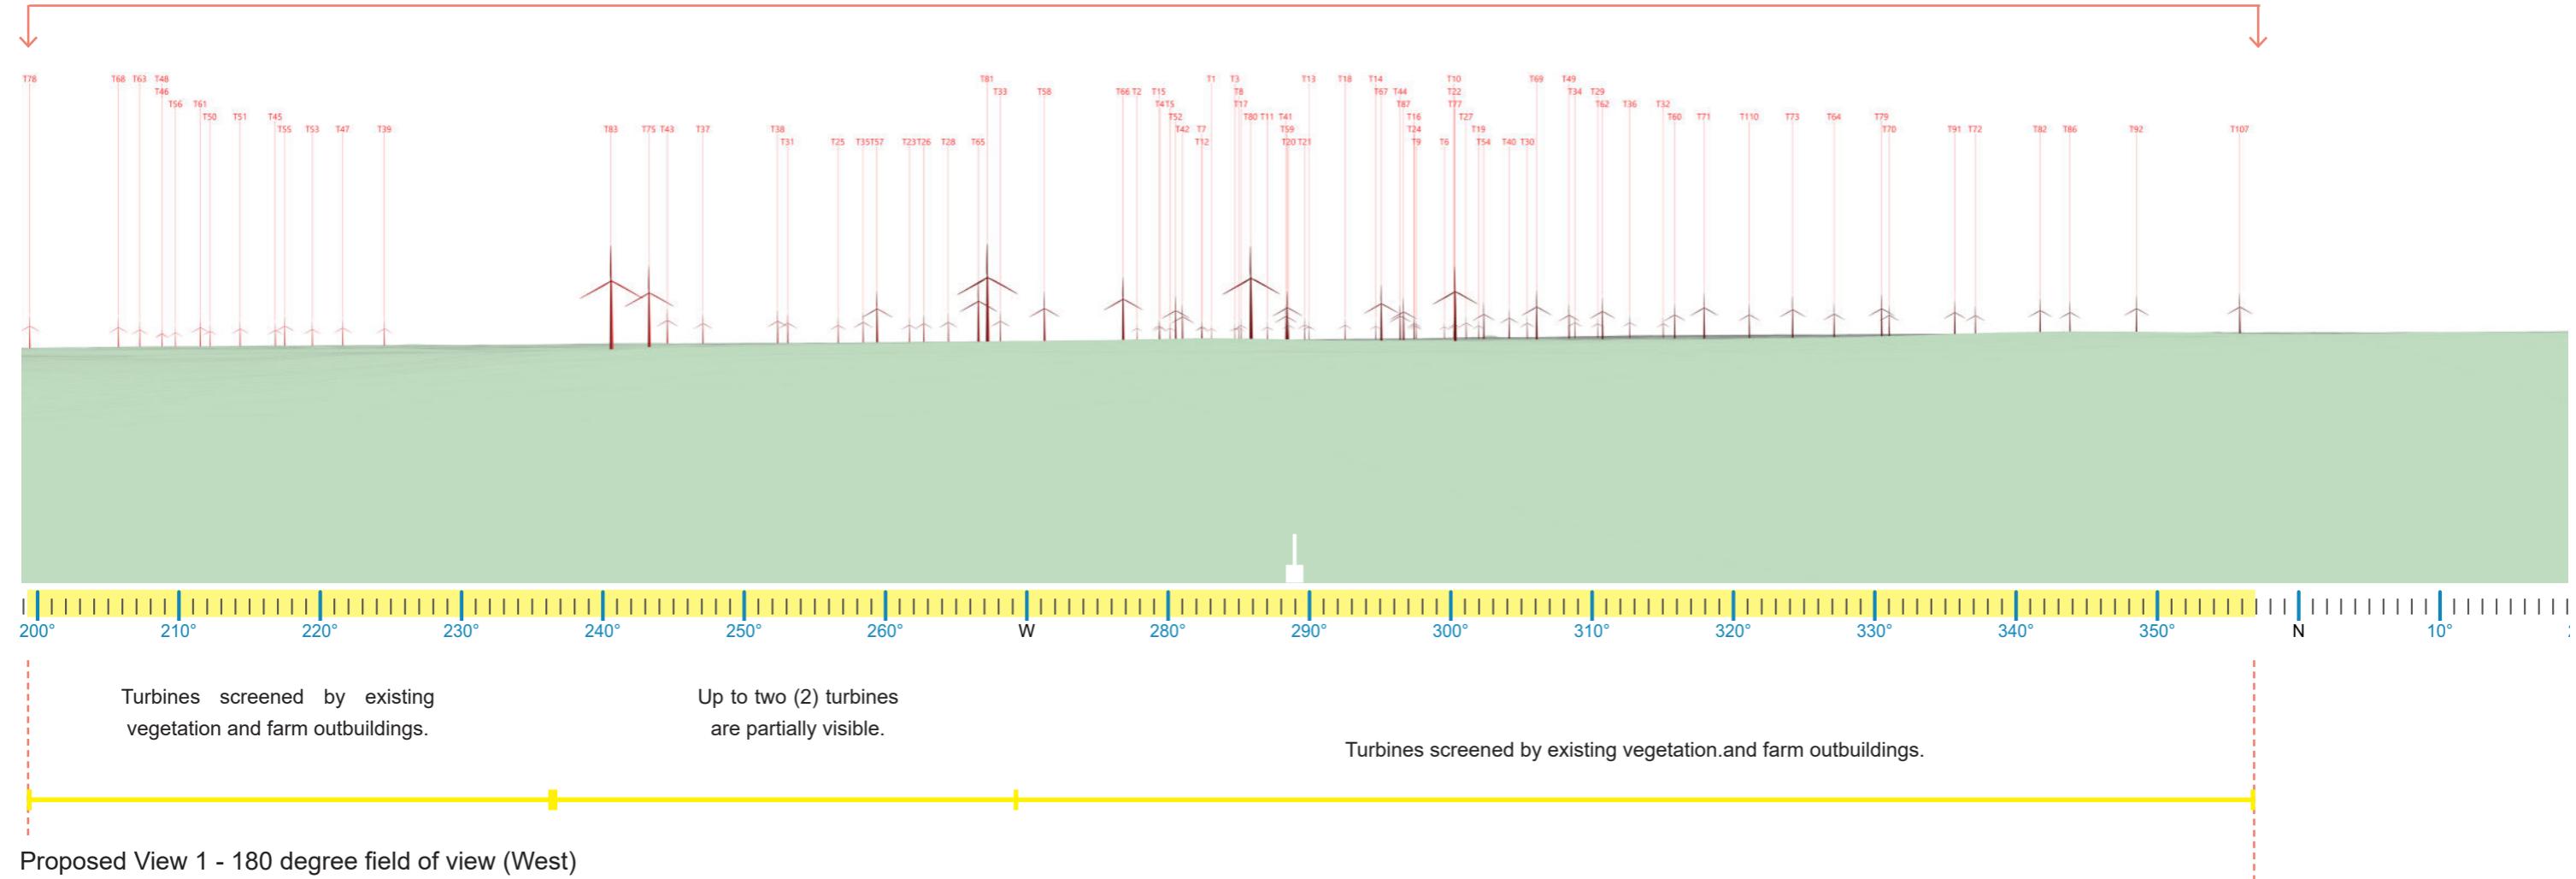
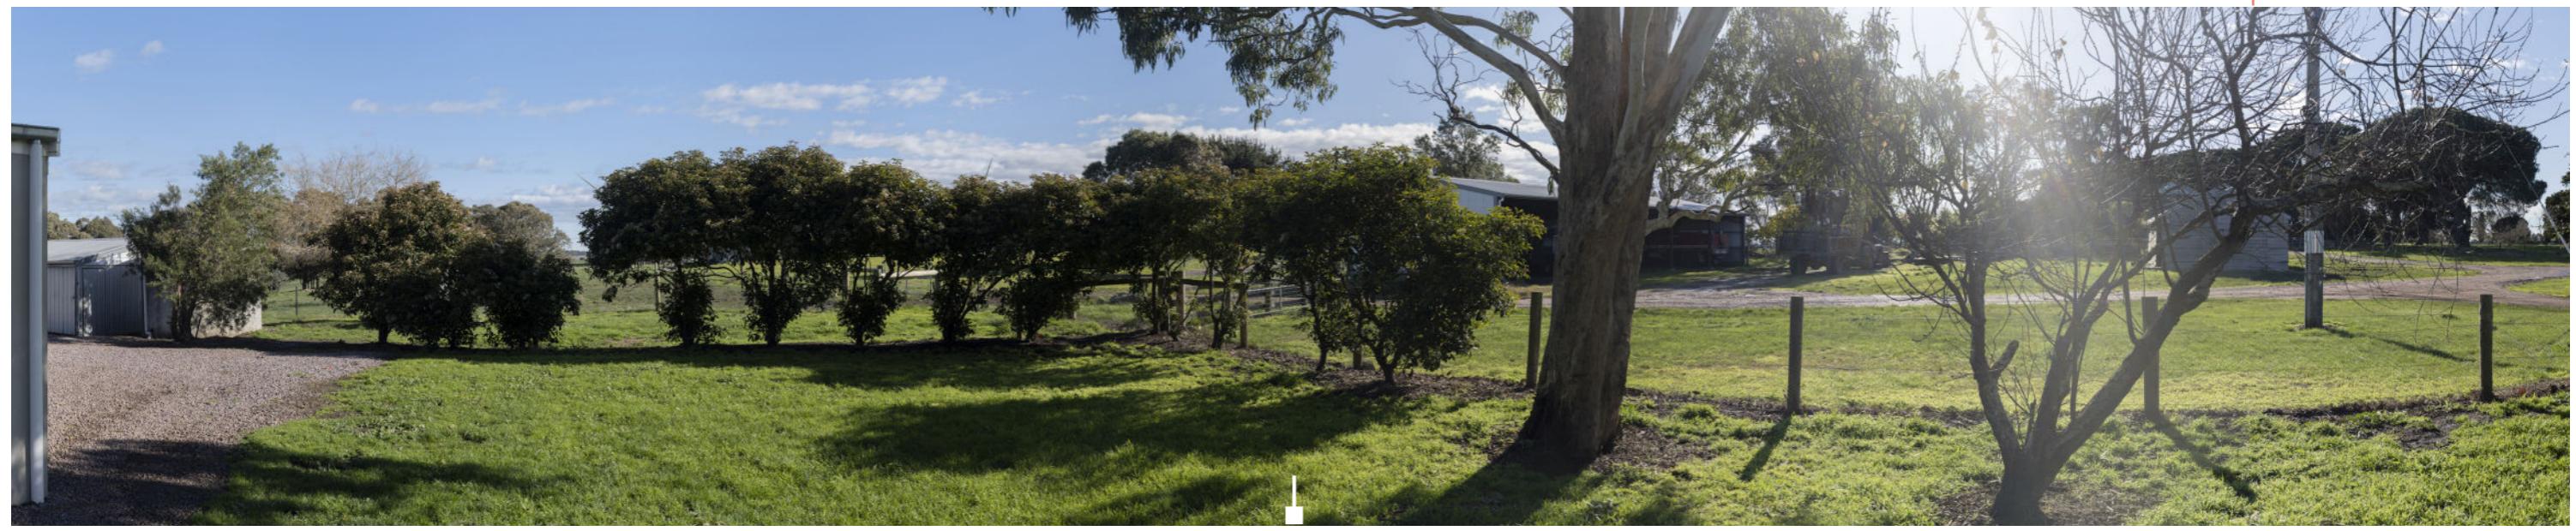
Proposed Wire Frame Diagram - 180 degree field of view

Wire Frame Diagram indicates 88 turbines at hub height are visible

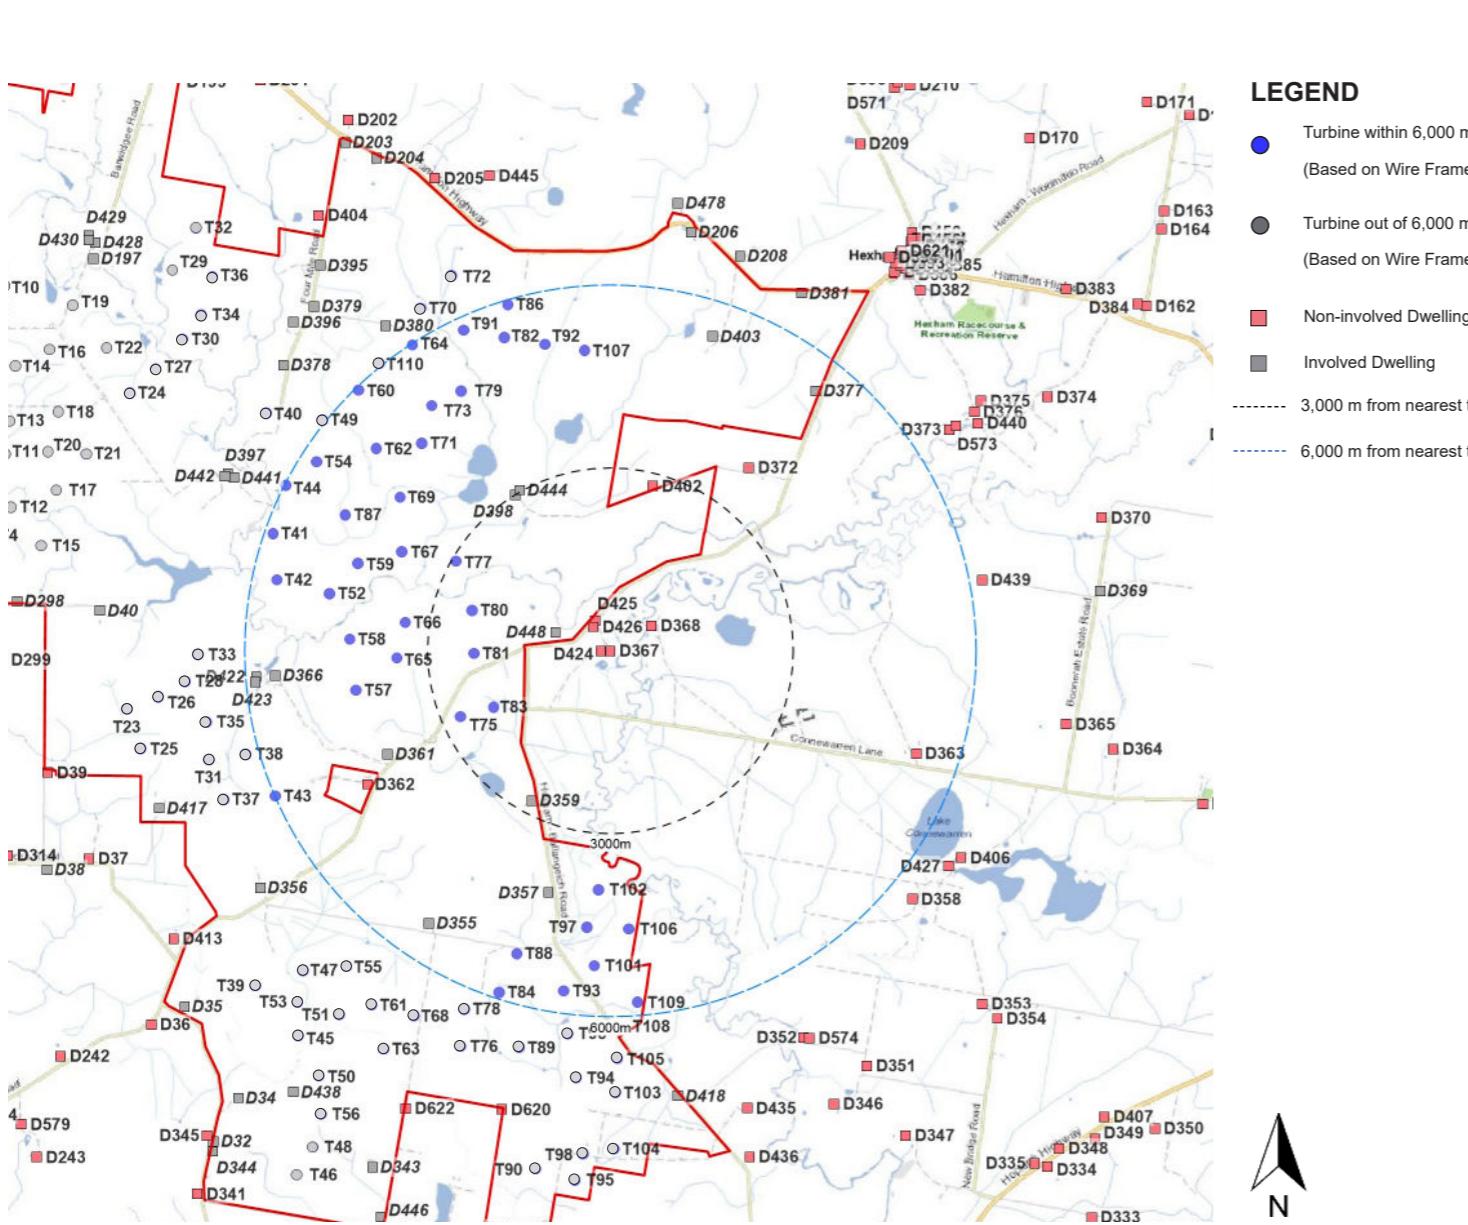
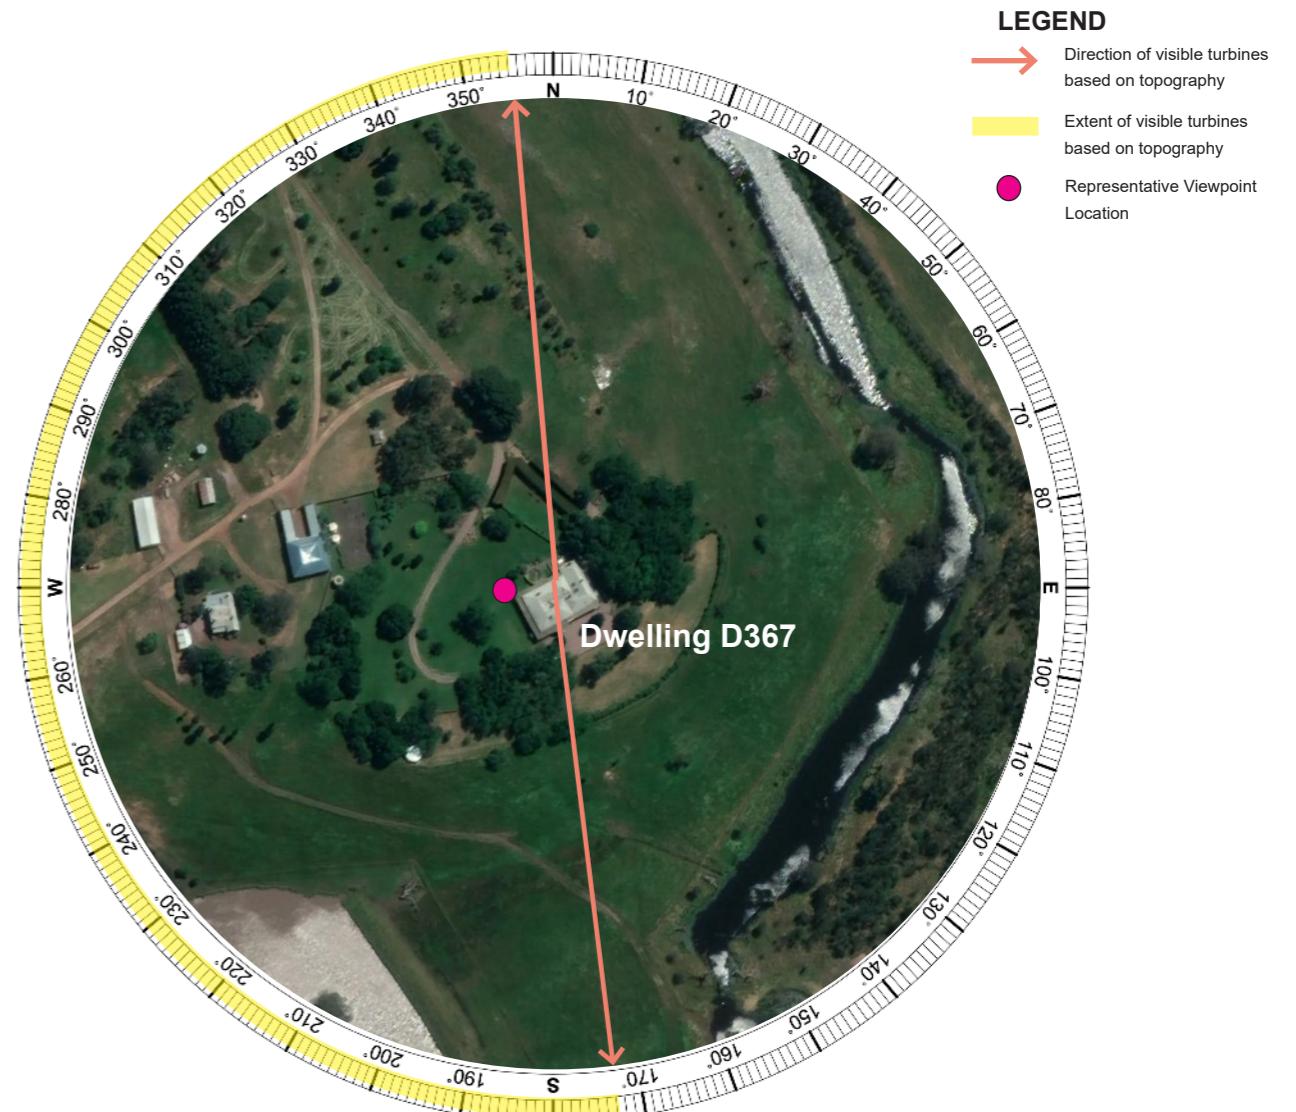
DWELLING D367

Nearest proposed turbine (km):	2.12 km	Viewer Sensitivity:	Moderate
Number of proposed turbines within 6,000m of the dwelling:	38	Scenic Quality Rating:	Low
Number of potentially visible turbines (Based on topography alone)	78	Landscape Character Unit:	LCU01

A site inspection was undertaken in July 2023 at this dwelling and a viewpoint was selected in consultation with the owner. The wire frame diagram prepared from the dwelling indicates that eighty (80) turbines would theoretically be visible based on topography alone. The nearest turbine is located approximately 2.12 km away to the southwest of the dwelling. On inspection it was found that the dwelling is surrounded by a row of deciduous trees to the south and southwest and dense vegetation to the north and west of the dwelling. A photomontage has been prepared to demonstrate the extent of visibility of the Project from the dwelling. It is likely that the majority of turbines will be screened by existing vegetation and partial views will be available to the south and southwest. It is likely that the Project will have a low impact on the scenic quality. The visual impact resulting from the Project has been rated as **Low**.

Existing vegetation will assist in screening view to the turbines. No mitigation required.

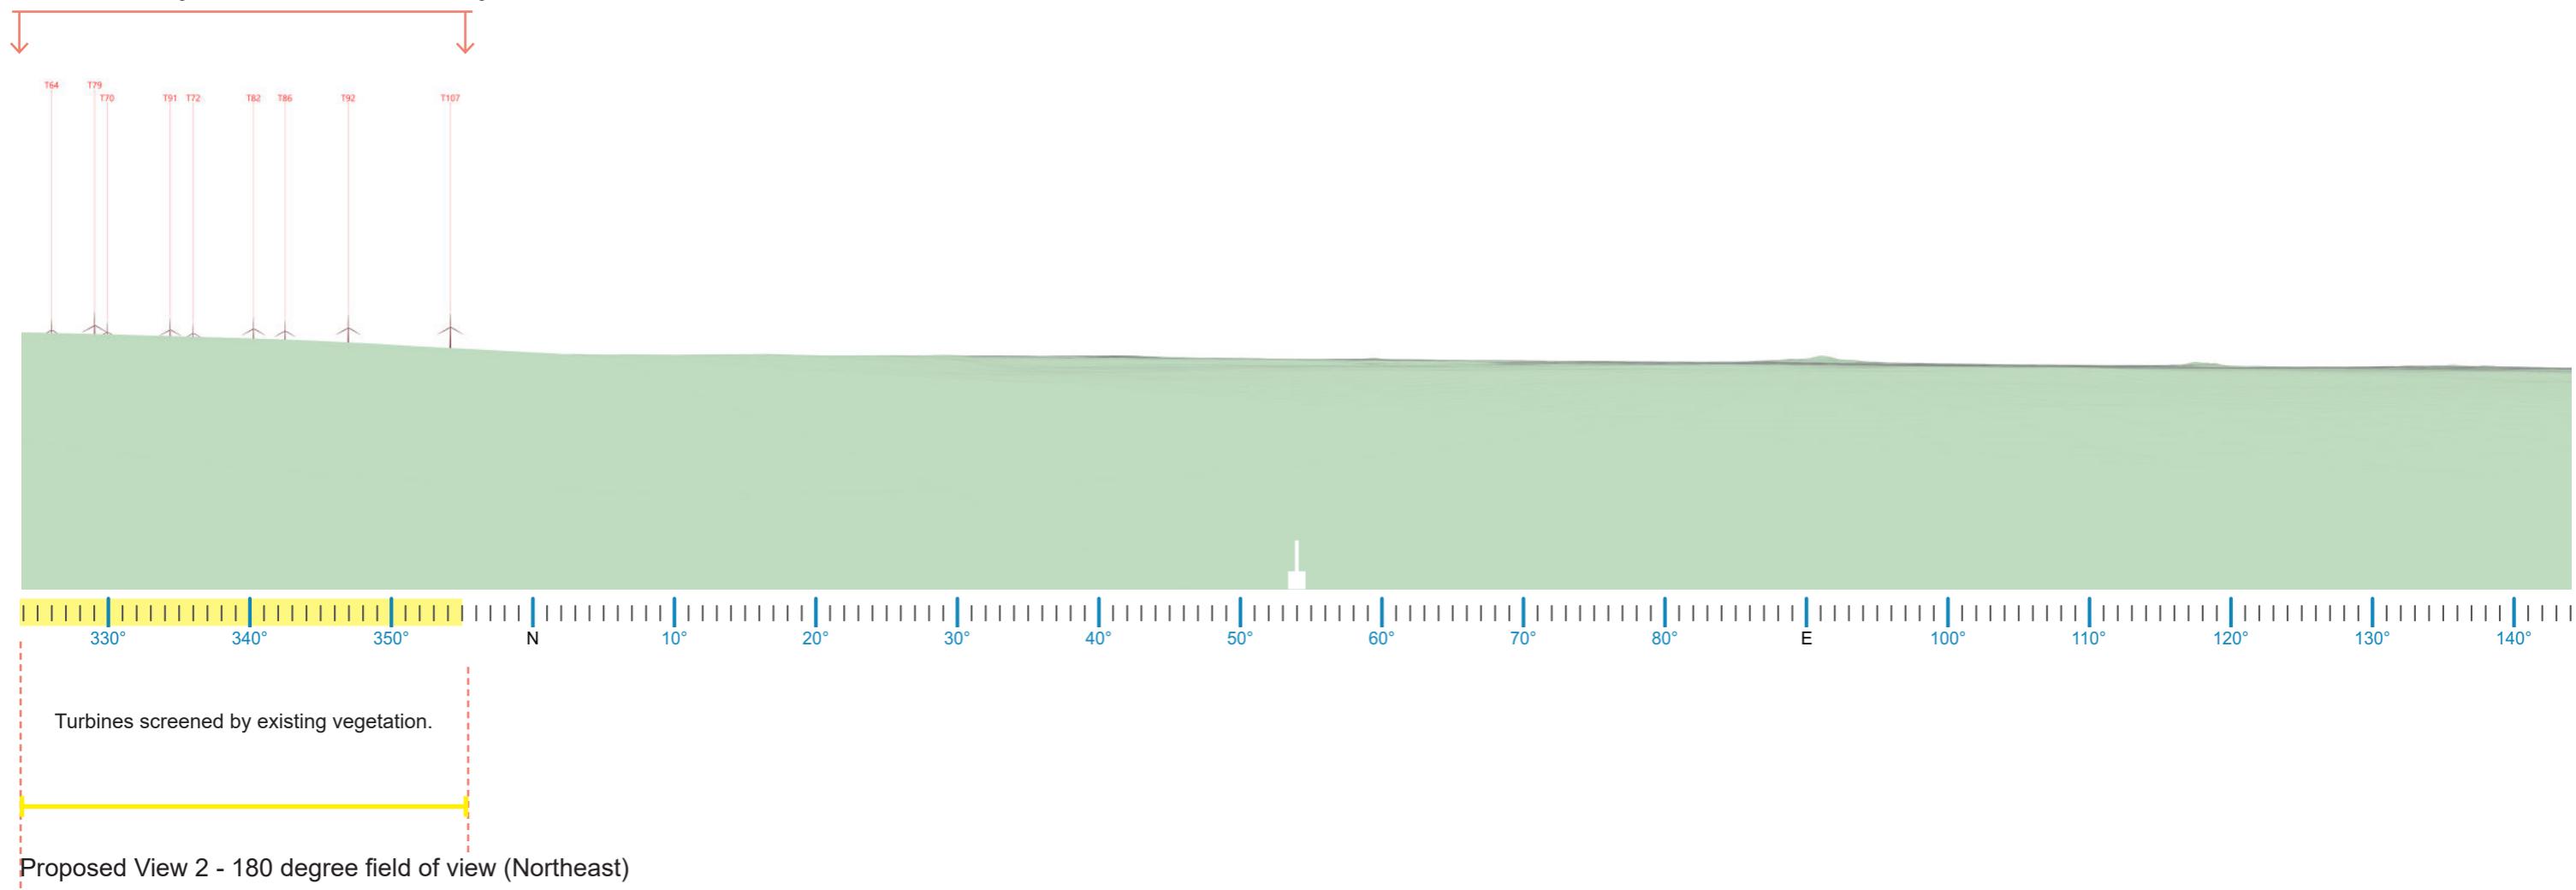
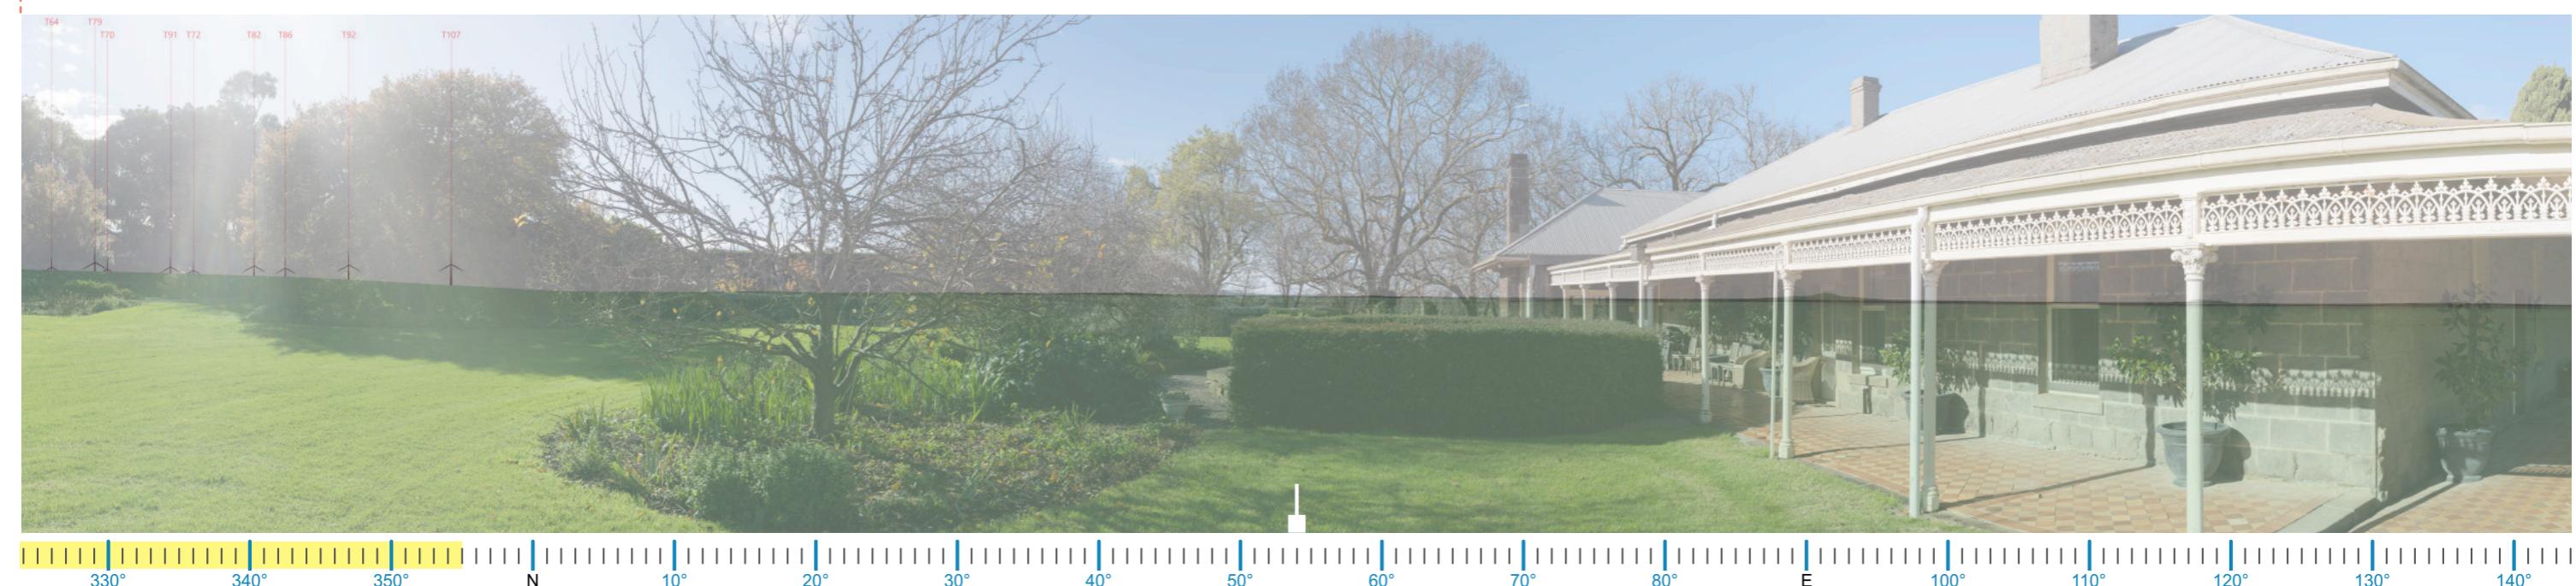
Proposed Wire Frame Diagram - 180 degree field of view

Wire Frame Diagram indicates 10 turbines at hub height are visible.

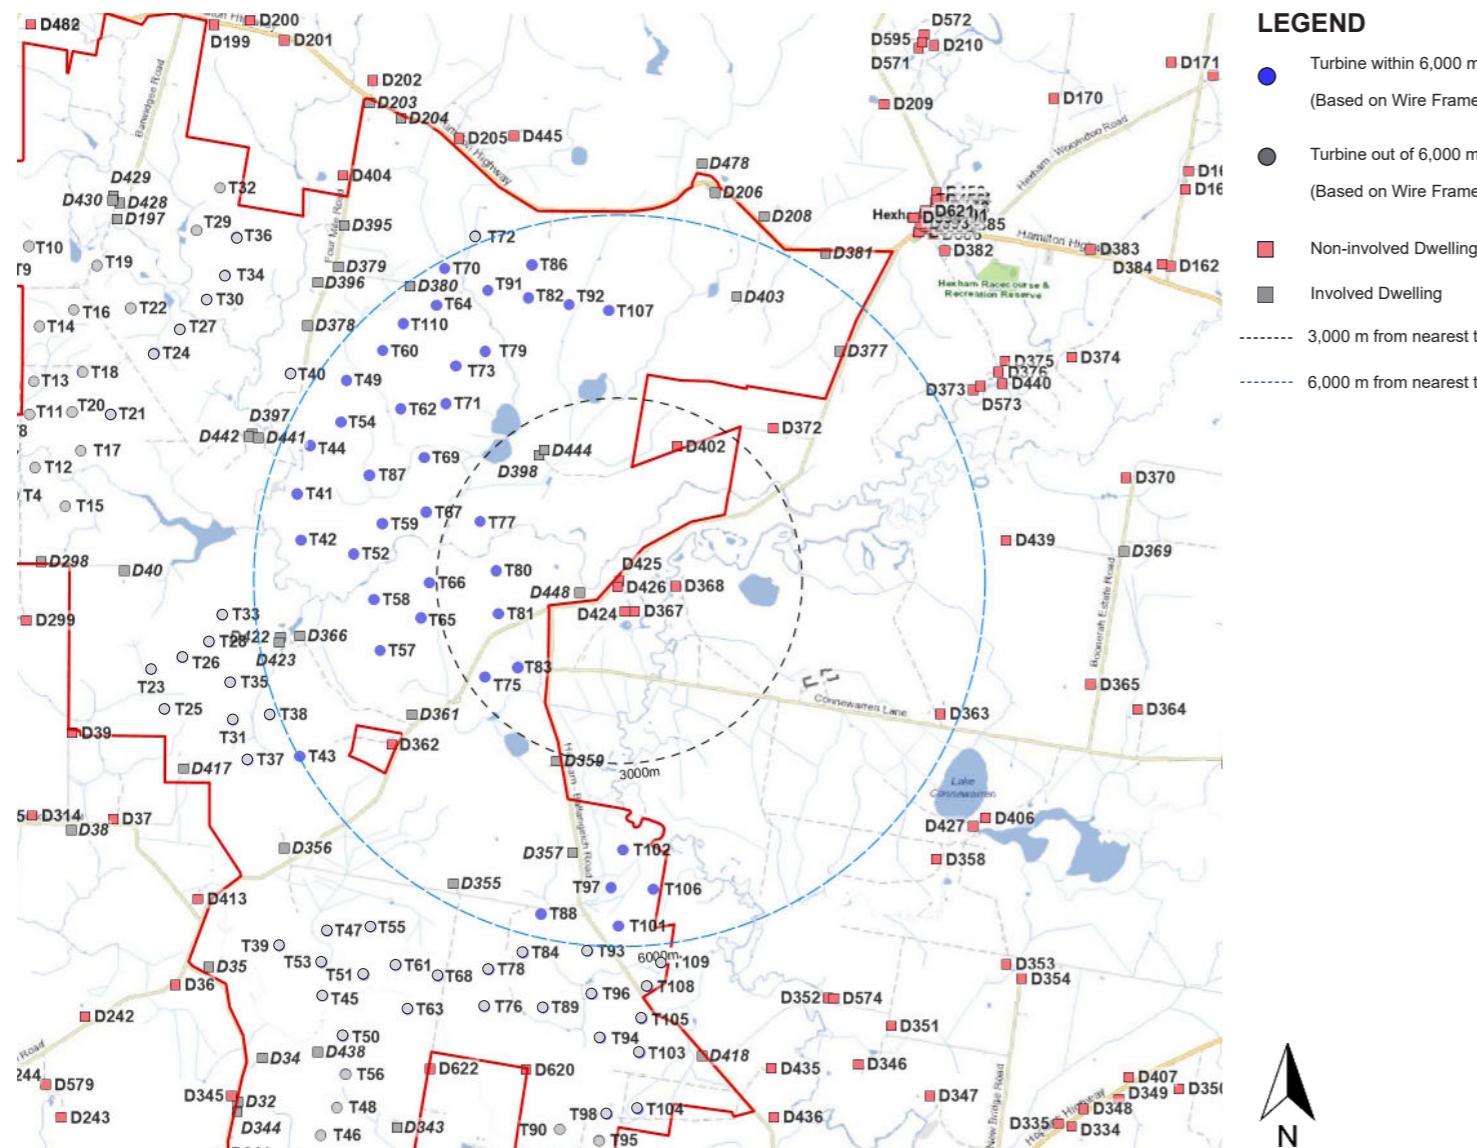
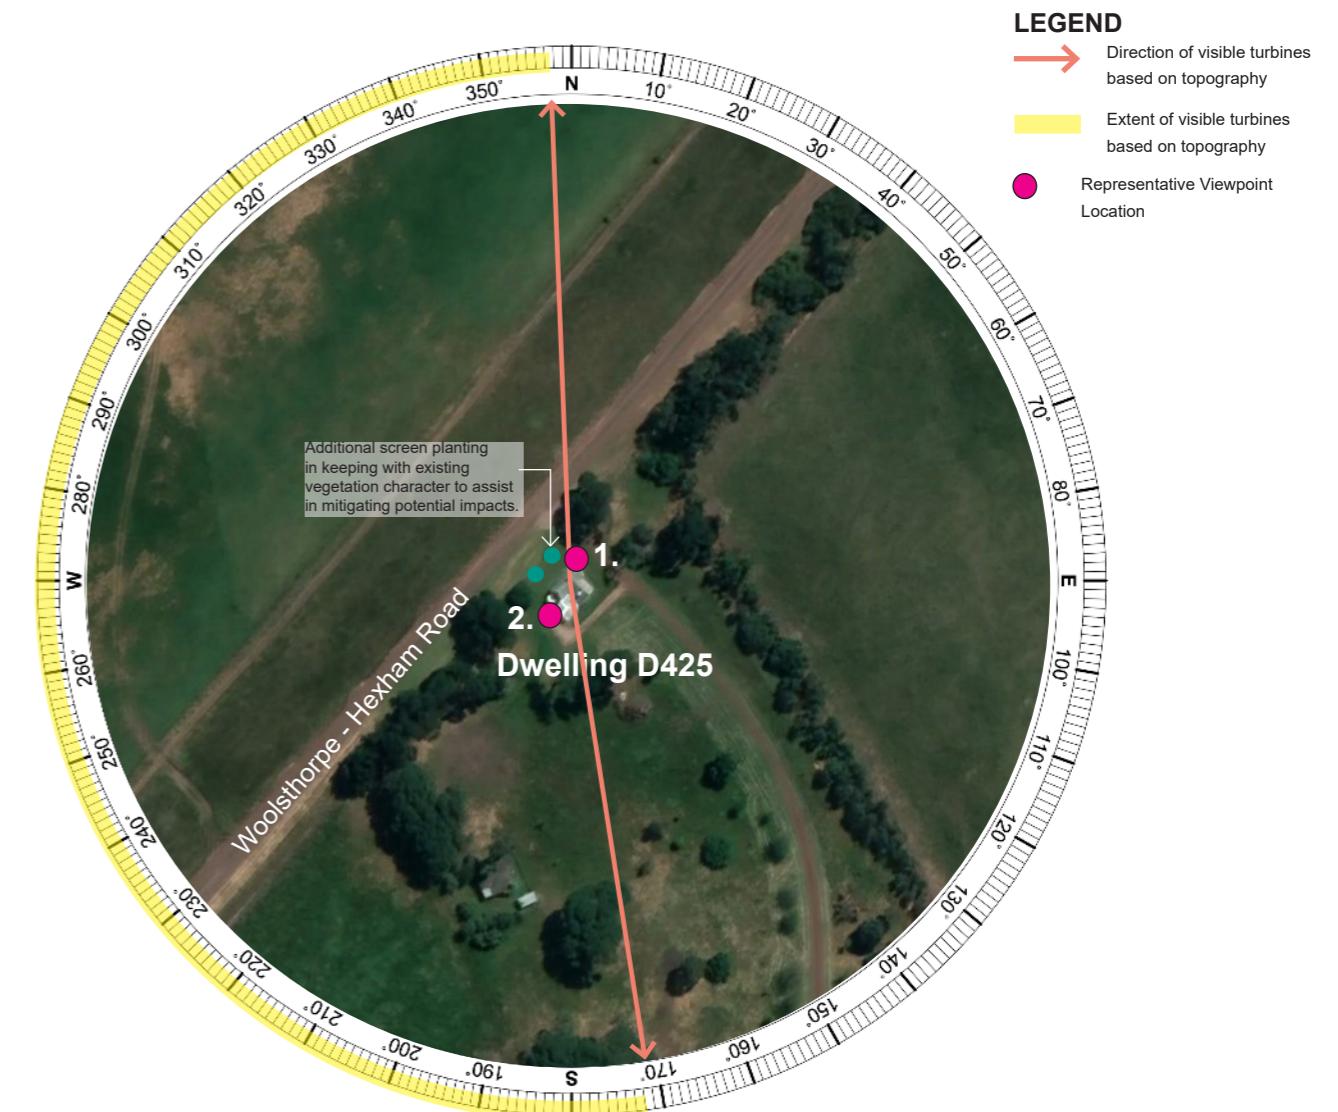
DWELLING D425			
Nearest proposed turbine (km):	2.02 km	Viewer Sensitivity:	Moderate
Number of proposed turbines within 6,000m of the dwelling:	38	Scenic Quality Rating:	Low
Number of potentially visible turbines (Based on topography alone)	106	Landscape Character Unit:	LCU01
Visual Impact Rating: Moderate

A site inspection was undertaken in July 2023 at this dwelling and a viewpoint was selected in consultation with the owner. The wire frame diagram prepared from the dwelling indicates all (106) turbines would theoretically be visible at hub height based on topography alone. The nearest turbine is located approximately 2.02 km to the west the dwelling. On inspection it was found that views to the north and northwest are open towards the Project. Gaps in existing vegetation on the south/southwestern side of the dwelling allow fragmented views to turbines in up to 100 degrees of the viewshed in this direction. A photomontage has been prepared to demonstrate the extent of visibility of the Project from the dwelling. It is likely that the Project will have a moderate impact on the scenic quality. The visual impact resulting from the Project has been rated as **Moderate**.

Provision of screen planting in the dwelling's foreground to the northwest would potentially reduce the visual impact to low as demonstrated in locations where existing windbreak planting is effective in screening views, however this will take time to establish. Consultation with the landowner is recommended to discuss appropriate mitigation.
