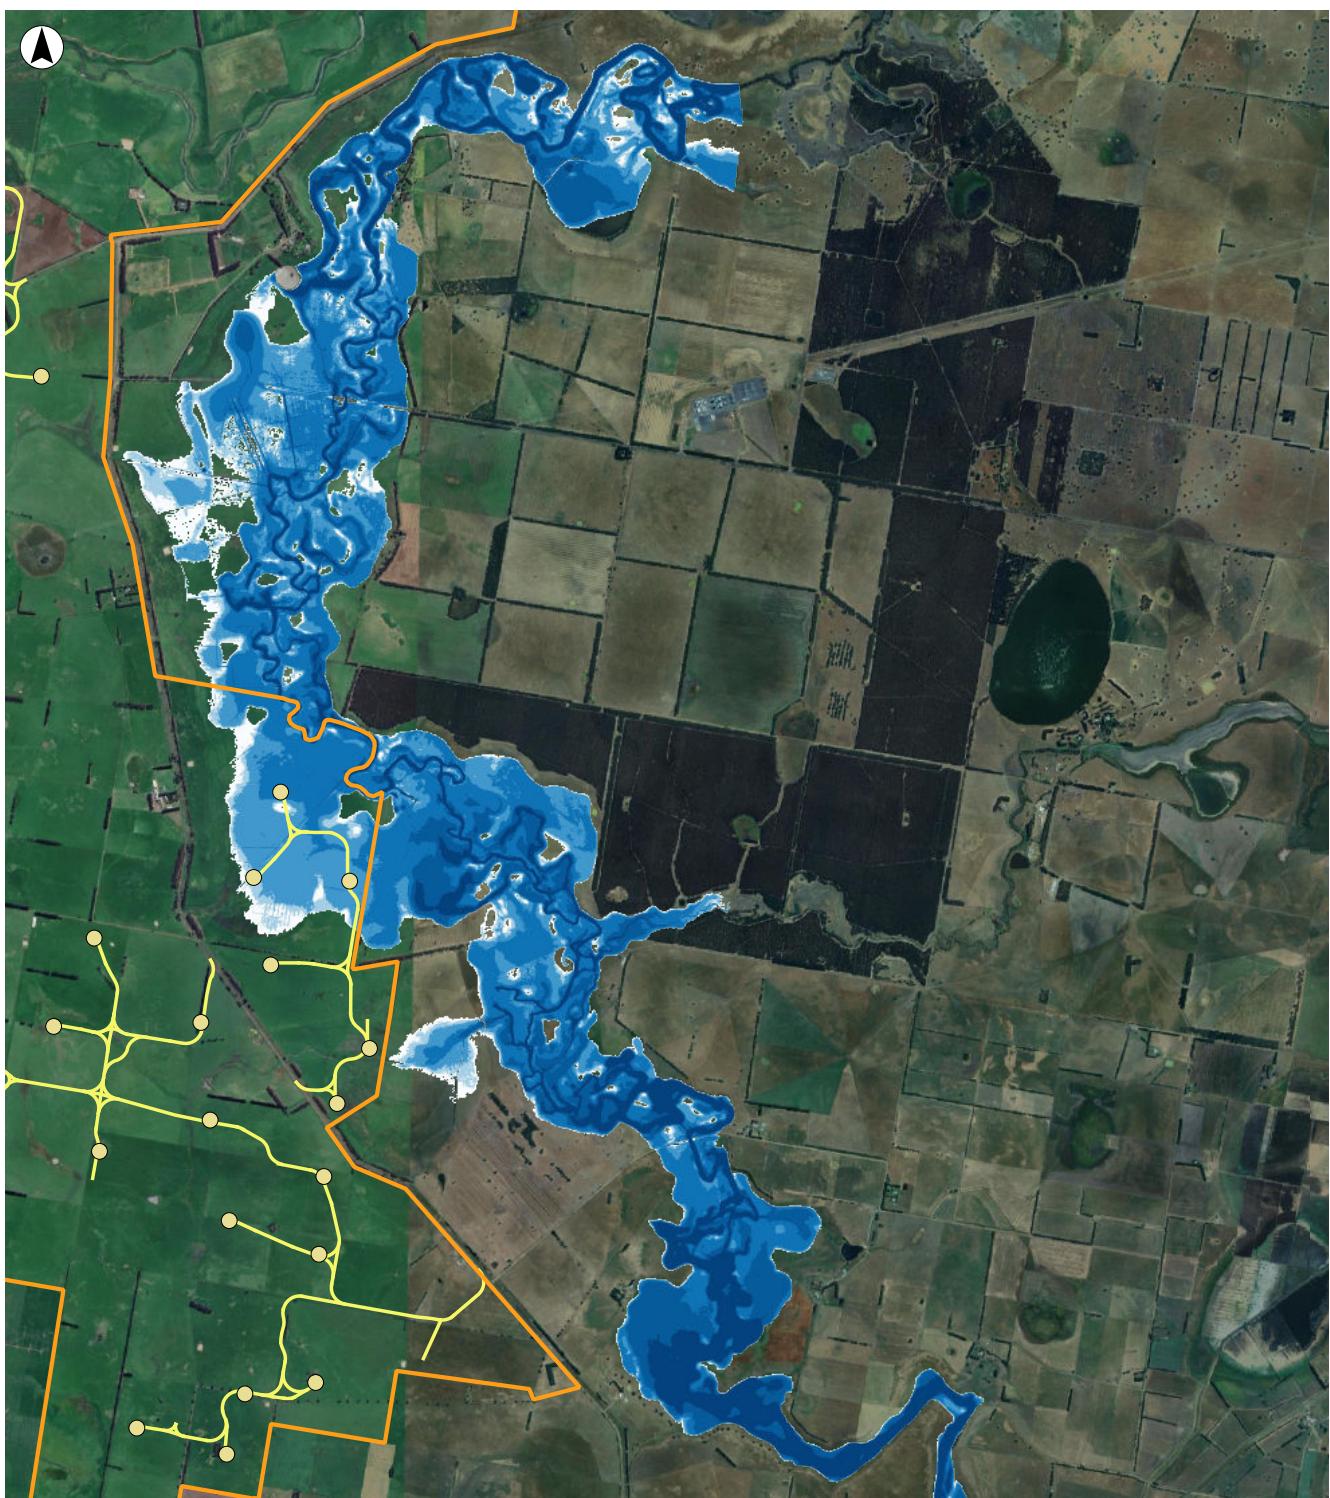
Figure 12.6 Modelled 1% AEP inundation for Hopkins River – existing conditions

Hydraulic modelling indicates that Mustons Creek breaks out of its banks and inundates a wider floodplain up to 400 metres wide during a 1% AEP flood event. The inundation from Tea Tree Creek, Lyall Creek and Drysdale Creek is less widespread, with pooling of water occurring in local depressions at various locations (Figure 12.6).

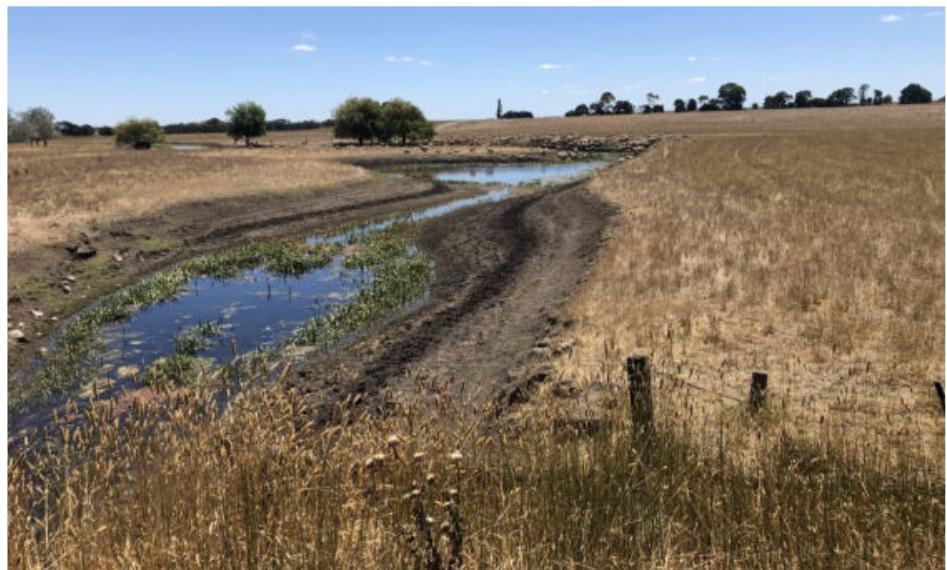
Figure 12.7
Mustons Creek 1.5
kilometres south of
confluence with Tea Tree
Creek (within project site)
(Source: Water Technology)

Figure 12.7 shows Mustons Creek within the project site. Figure 12.8 and Figure 12.9 show Burchett Creek and Tea Tree Creek at the northern boundary of the project site.

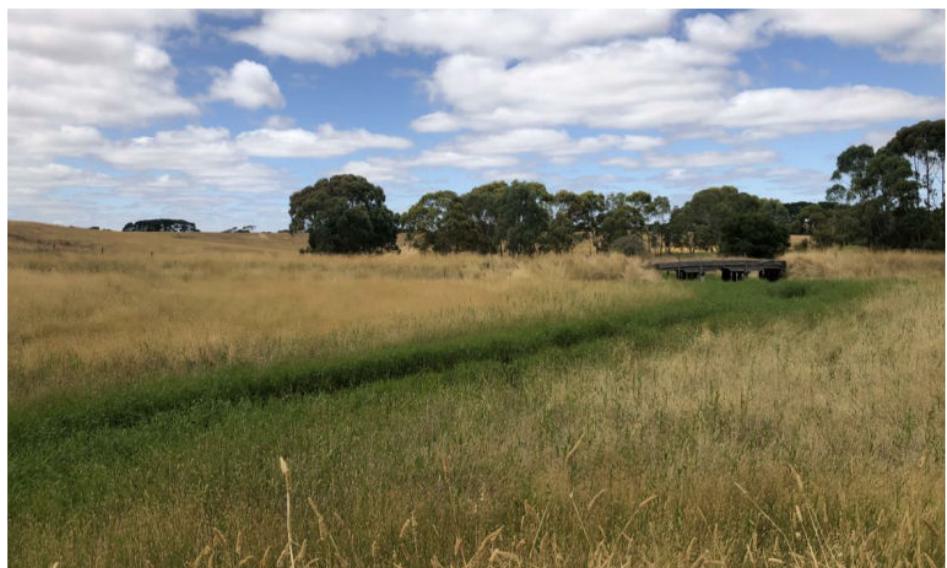
Figure 12.8
Burchett Creek at Caramut
(northern-most extent of the
project site)
(Source: Water Technology)

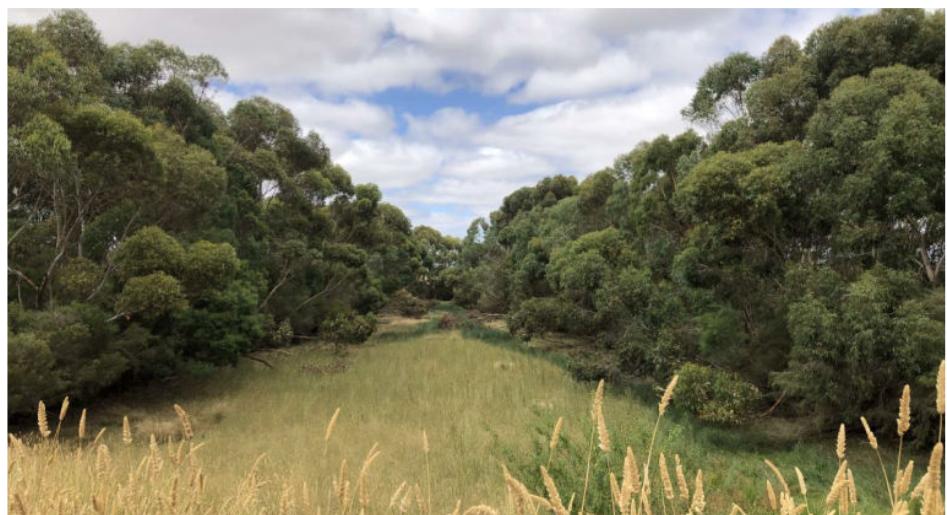
Figure 12.9
Tea Tree Creek at Hamilton
Highway, 10 kilometres
west of Hexham (adjacent
to northern project site
boundary)
(Source: Water Technology)

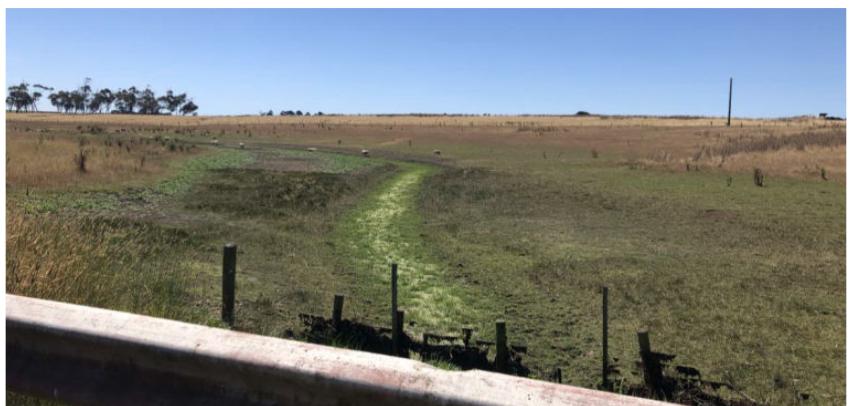
Figure 12.10

Drysdale Creek at Gordons Lane,
3.5 kilometres west of Ellerslie (east of
southern project site boundary)
